Black Hills Inspection Services

Confidential - Property Inspection Report - Confidential

123 Black Hills Rd., Paradise SD, 57xxx
Inspection prepared for: Sample Homeowner
Agent: Worx Forclient - Client's Preferred Real Estate

Inspection Date: 5/28/2010
Age: 11 y.o. Size: 1300 sq. ft.
Weather: Cool, Dry

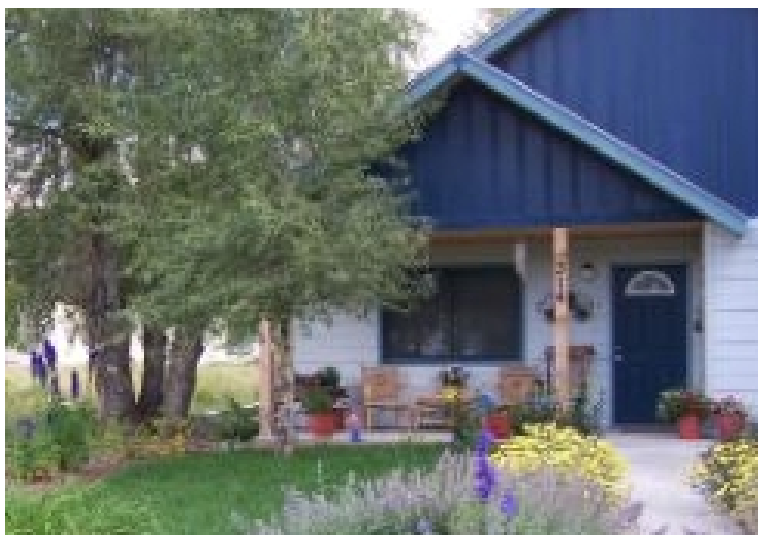
- **MONITOR:** There are large trees in close proximity to the home particular at NE corner. Over time, trees can potentially damage the home, although no signs of that currently. Large trees should be reviewed annually for pruning, de-limbing, or potential removal.

Monitor Foundation near large tree. Currently no issues observed.

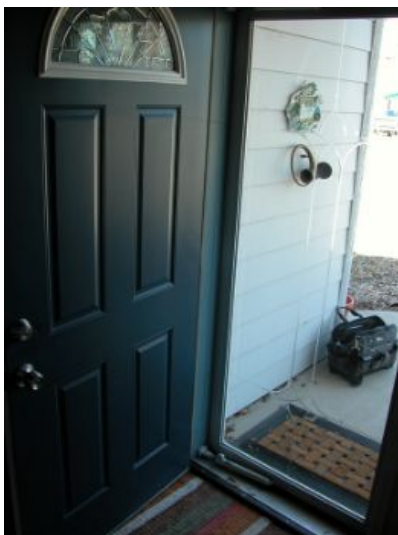
Front Entrance. All exterior Doors seal effectively.

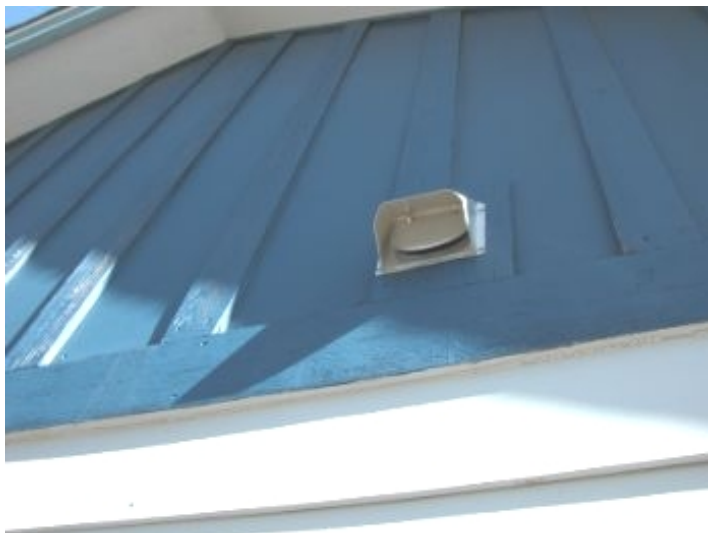
Paint in good shape, external dryer vent functional.

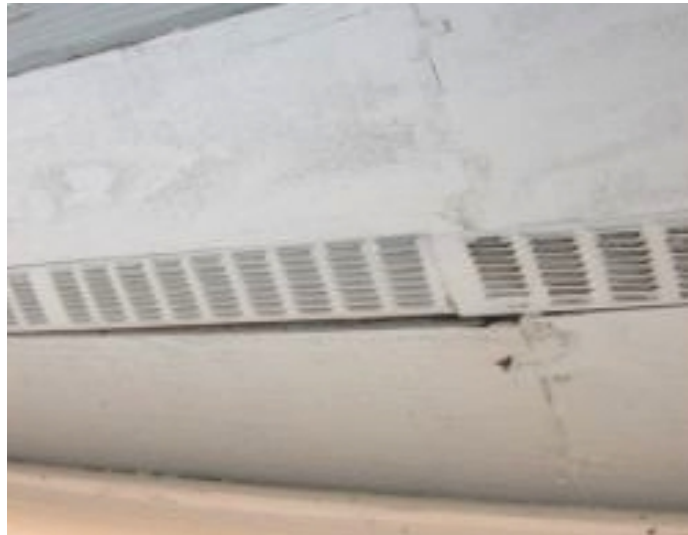
- East side appeared to be in serviceable condition, at time of inspection. West side had one vent area where moisture affect was noted. This could be access point for insects. Caulk and repair as needed to prevent further deterioration.

Area of soffet needing maintenance caulking.

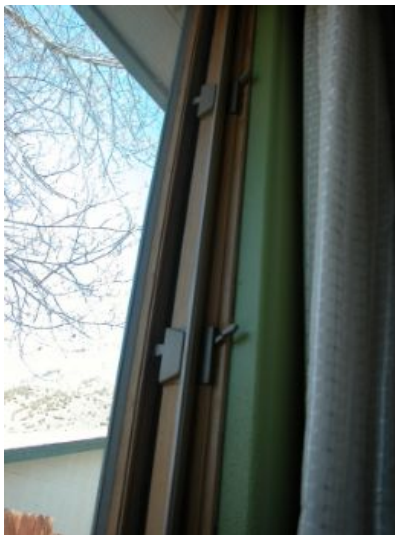
Some window-latch adjustment needed.

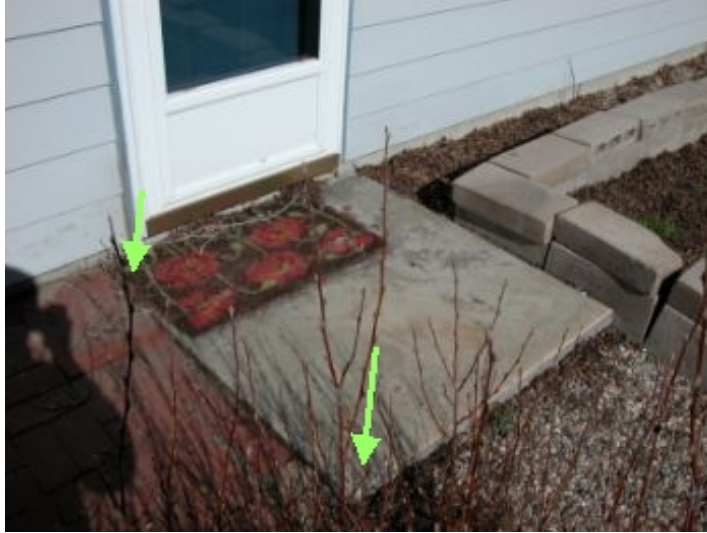
- The east side door porch is settled. This may be due to erosion over time. Monitor or repair as needed. Mud-jacking could resolve this, but ensure drainage is not future cause for concern.

Some settlement of side porch.

Page 6 Item: 10	Steps, Stoop, Porch	• The east side door porch is settled. This may be due to erosion over time. Monitor or repair as needed. Mud-jacking could resolve this, but ensure drainage is not future cause for concern.
-----------------	---------------------	--

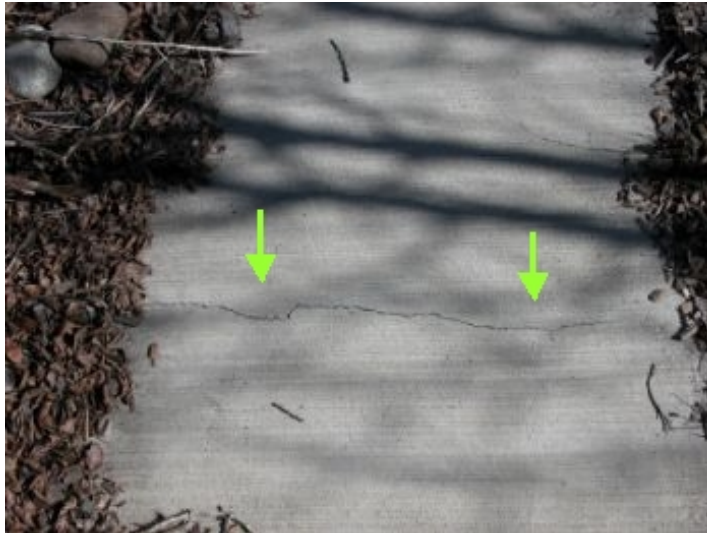
- Appeared mostly functional and satisfactory, at time of inspection. However a small crack noted on one panel. This may be patched, but monitor regardless. As it worsens in time, repair will likely be required.

Minor crack in walkway.

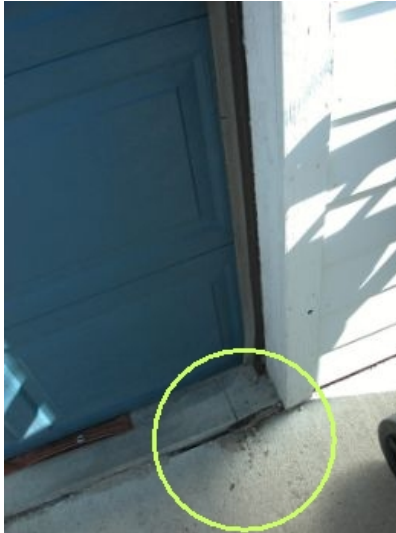
- Where drive meets garage, expansion-joint wear is noted. Consider repair with flexible concrete caulk.

Caulk and Seal to stop further erosion.

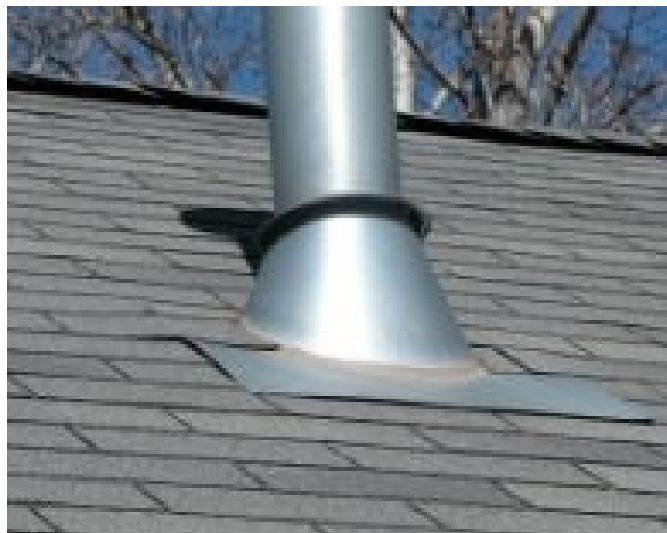
Flue stack properly flashed.

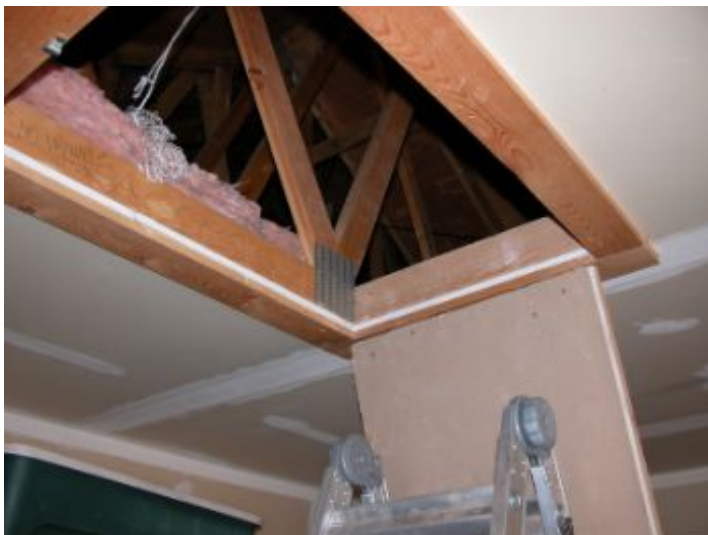
Primary attic access reveals insulated garage ceiling.

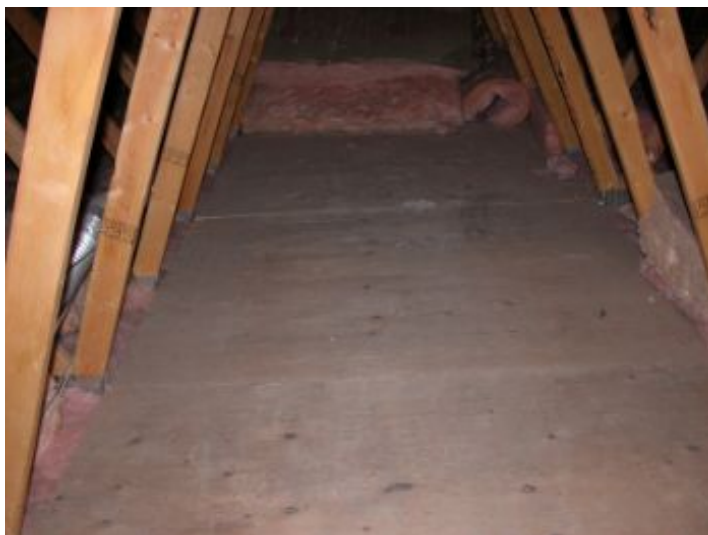
Attic walkable and storage capable.

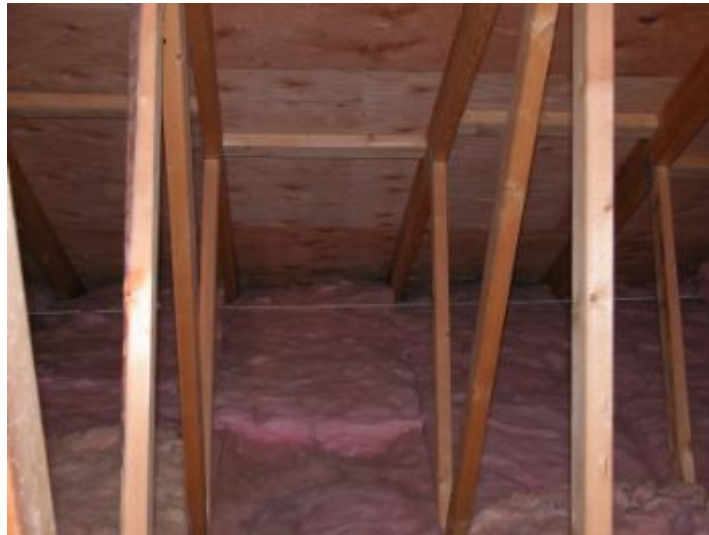
Very well-insulated.

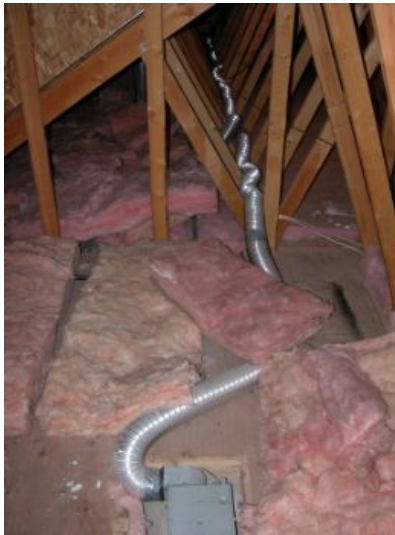
Bath fan vents appropriately vented to exterior.

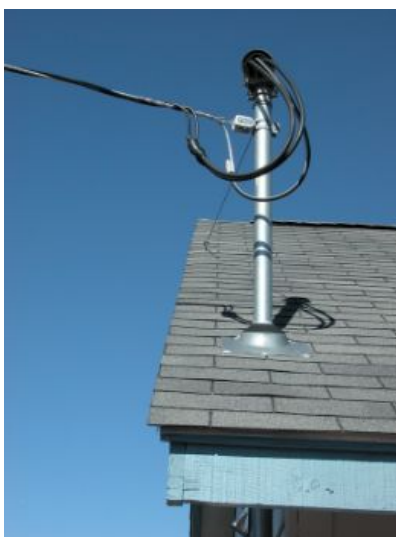
Electrical Service Drop

- The service drop was in particularly good condition, with proper drip loop, clearance and sturdy installation.

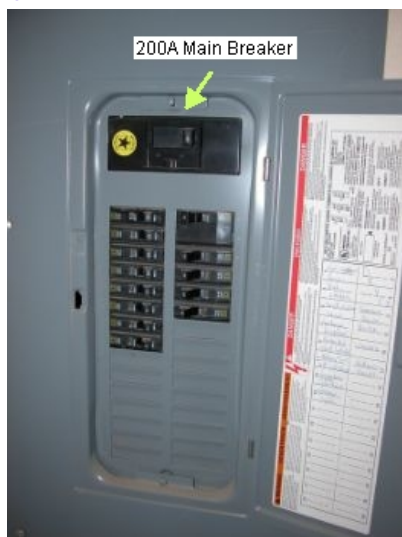
Clean well-mark QO Service panel with expansion slots.

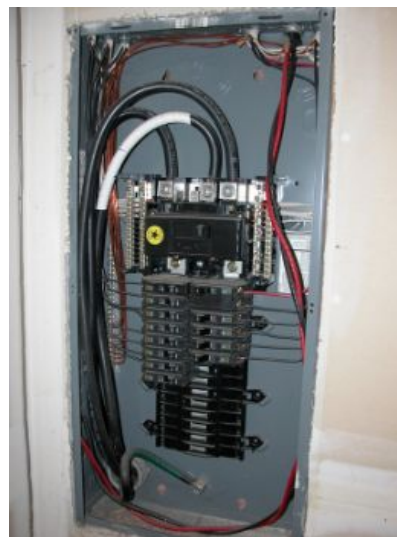
Electric Panel clean & properly configured.

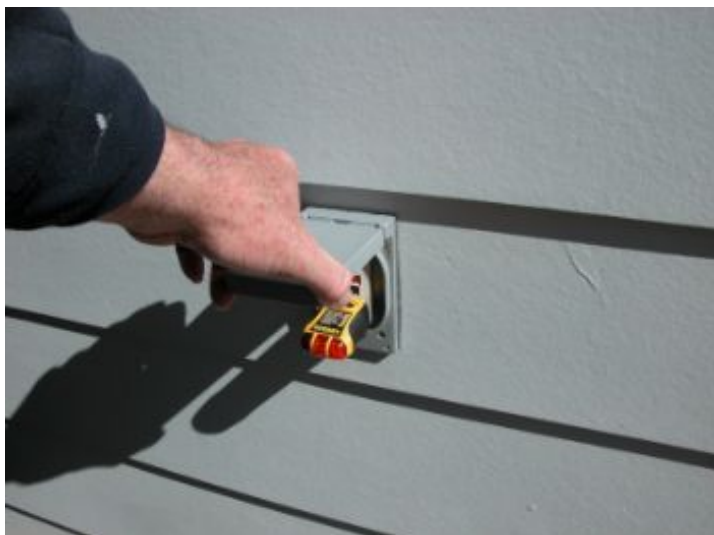
Proper exterior GFCI outlet shows functional

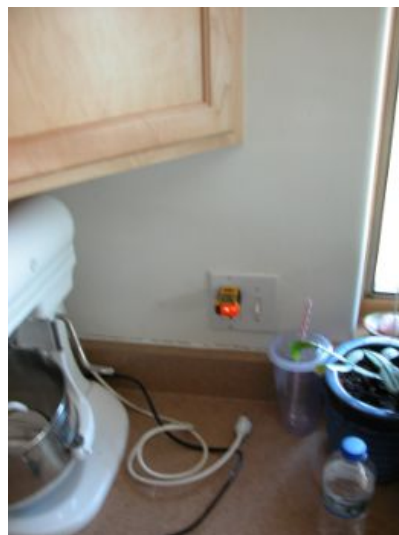
Ground fault circuit protected.

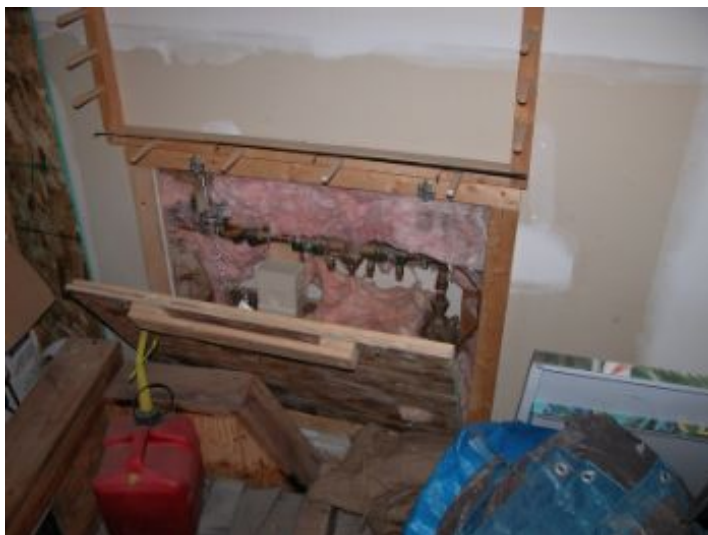
Primary water entrance panel from garage. Proper insulation.

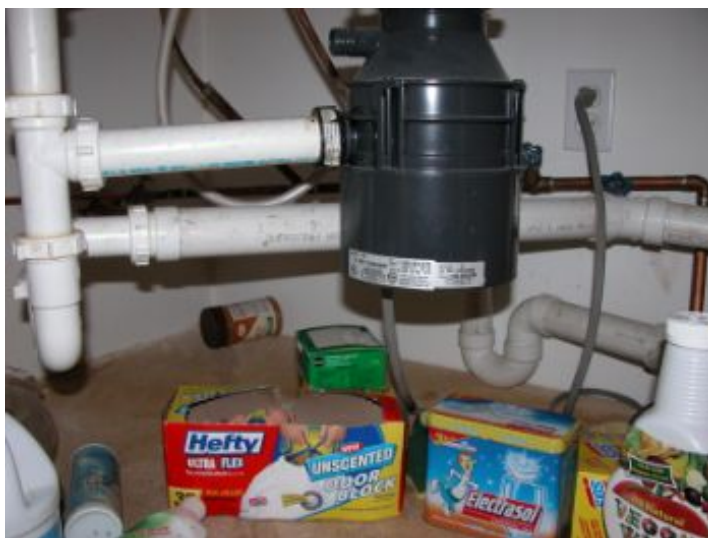
Under sink drains, properly plumbed with no leaks noted.

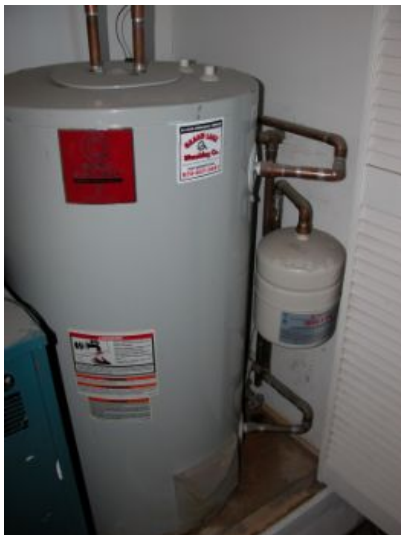
- This system is located in the plumbing closet between laundry room and garage. It is a two component system that addresses both the home heating (via radiant floor heat) and the interior hot water. The system consist of a gas-fired water boiler and an indirect water heater tank.
- Homeowner expressed concerns with function of water heater aspect of the heating system. Homeowner indicated that past problems had occurred including discharge of water heater via TPR valve. Some interior closet water staining was noted, as was rust on the bottom of heater. No drain was apparent in closet. Appeared that TPR valve was leaking into plastic container near time of inspection. Homeowner also states that hot water heater only operates when radiant heat system is active. This is not properly functional and a problem during the warmer months due to energy-inefficiencies and comfort.

WH at end of life, recommend replacement, decouple from radiant.

Replace indirect hot water heater, and have overall system serviced by a licensed plumbing contractor to resolve functional issues. Consider decoupling water heating from shared boiler with new hot water heater and dedicate existing boiler to radiant heat. This may provide an approach to cost-effectively resolve system problems. Add closet drain for TPR discharge pipe if feasible.

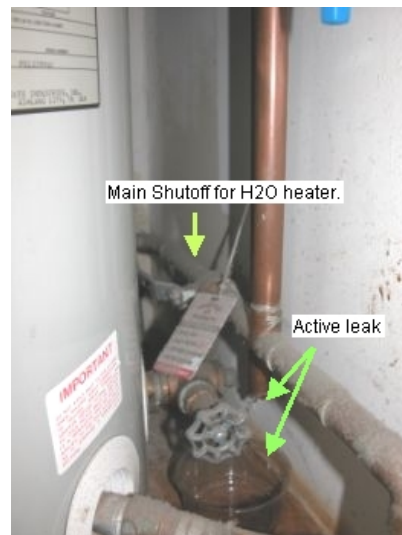
Evidence of TPR leaking.

Page 20 Item: 11	Water Heater(s) Condition	• Homeowner expressed concerns with function of water heater aspect of the heating system. Homeowner indicated that past problems had occurred including discharge of water heater via TPR valve. Some interior closet water staining was noted, as was rust on the bottom of heater. No drain was apparent in closet. Appeared that TPR valve was leaking into plastic container near time of inspection. Homeowner also states that hot water heater only operates when radiant heat system is active. This is not properly functional and a problem during the warmer months due to energy-inefficiencies and comfort. Please note that inspector is not a licensed plumber or HVAC contractor. Therefore any recommendations made by inspector should first be reviewed with appropriate licensed contractor prior to implementation. In this case, inspector suggests the following: Replace indirect hot water heater, and have overall system serviced by a licensed plumbing contractor to resolve functional issues. Consider decoupling water heating from shared boiler with new hot water heater and dedicate existing boiler to radiant heat. This may provide an approach to cost-effectively resolve system problems. Add closet drain for TPR discharge pipe if feasible.

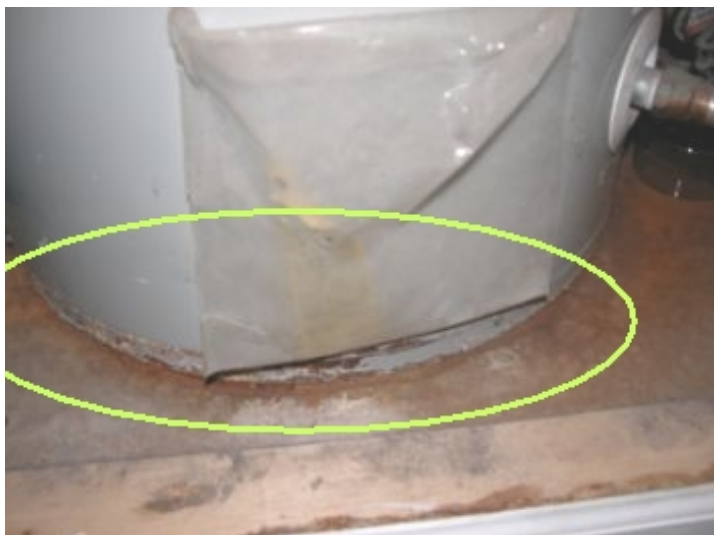
Water Heater show signs of rust/age, water stain on base.

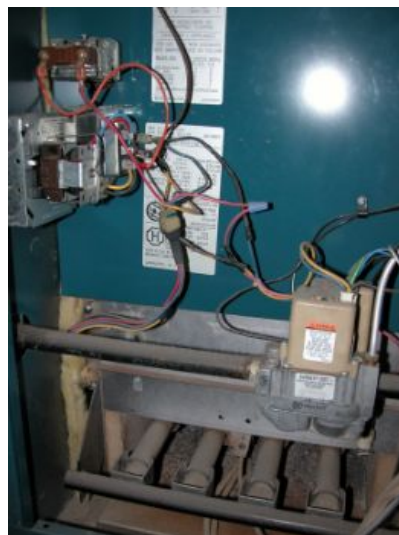
Boiler for hot water and radiant heat burns clean.

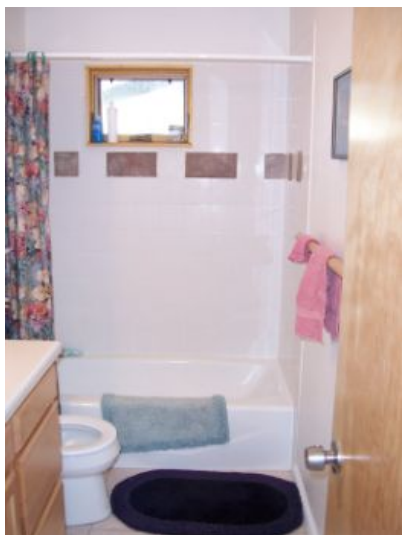
Hall bath with no problems noted.

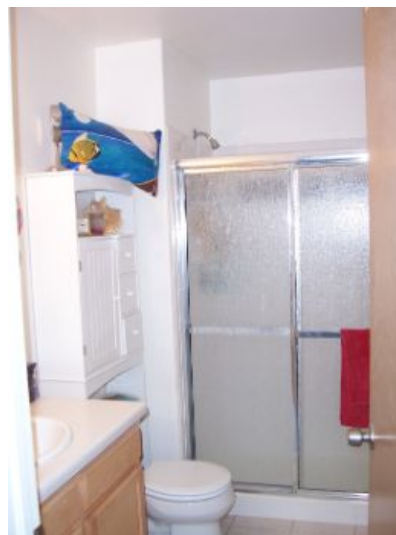
Master bath with no problems noted.

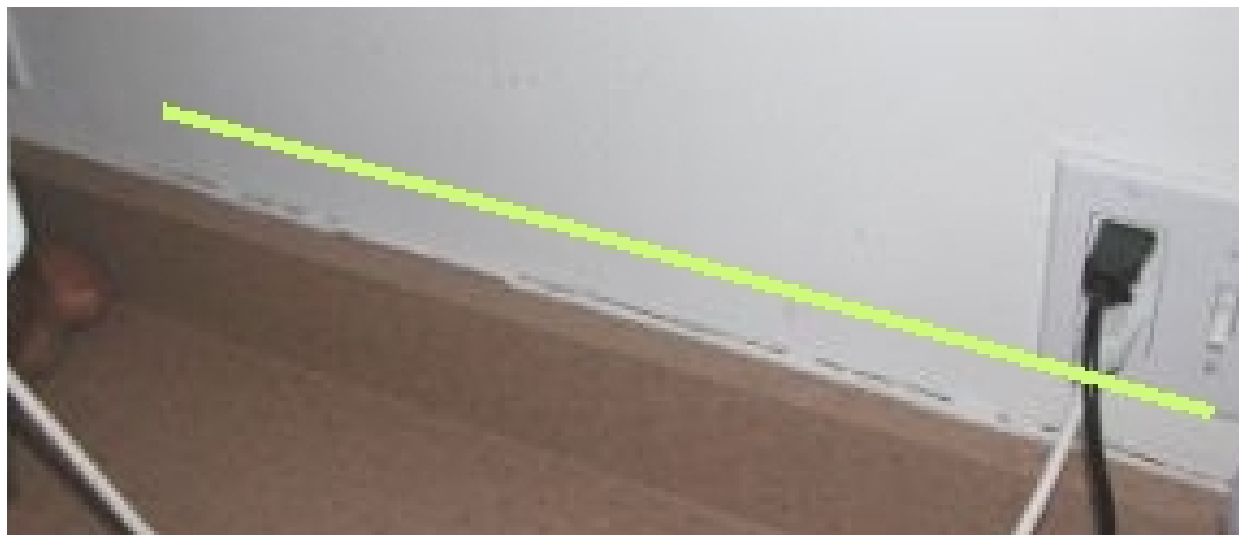
- No discrepancies noted, with normal wear for age. Some caulking maintenance needed as shown.

Re-caulk countertop advised.

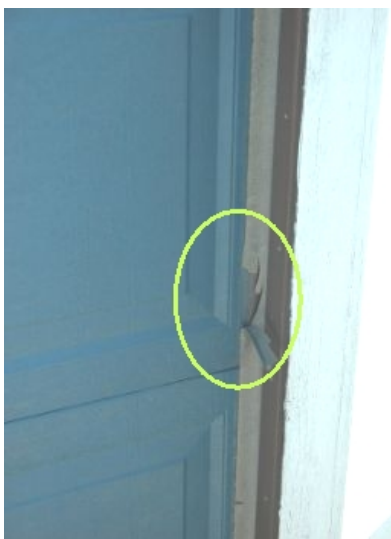
- Maintenance repairs suggested for weather sealant around exterior of door.

Weather seal repair recommended for garage door.

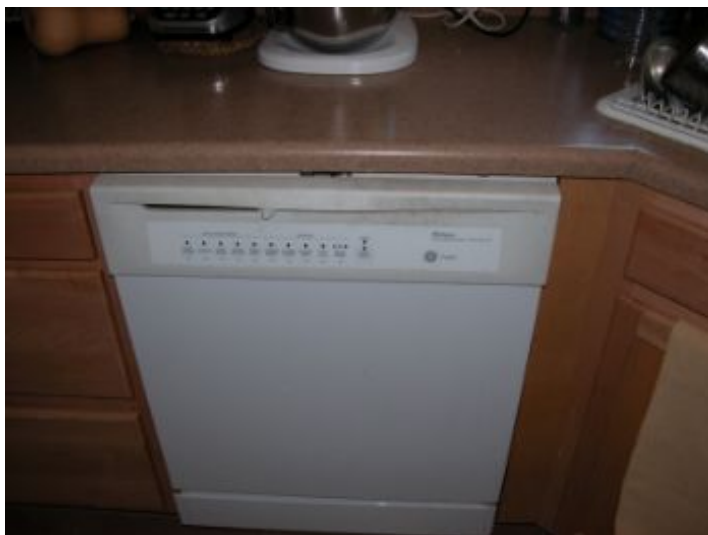
Tested Functional.

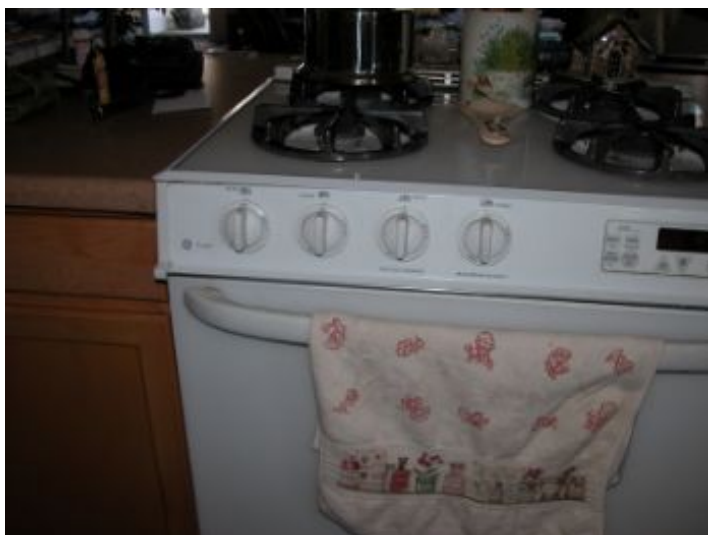
Performed as functional.

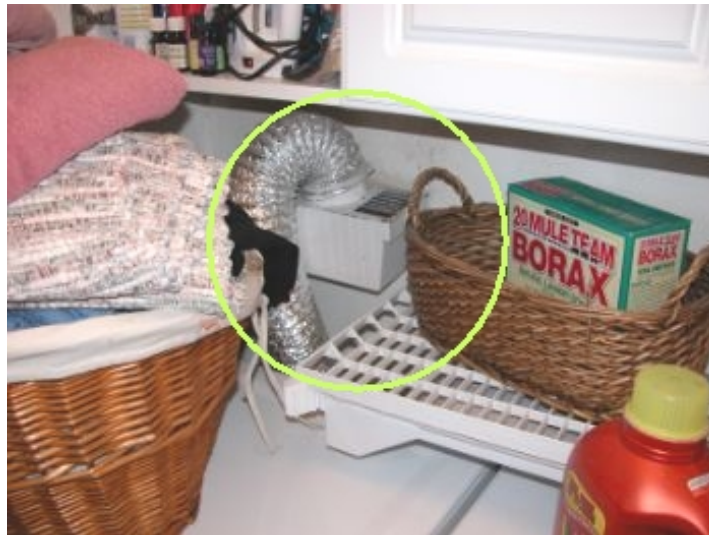
- Appeared functional, at time of inspection. Homeowner is using an internal dryer vent to enhance humidity level in home. This vent is installed under cabinets with flow directed toward cabinets. This could lead to moisture impact on cabinet in time. There is also a vent pipe to outside installed. Suggest use of this vent instead.

Internal dryer vent to enhance humidity in home. Remount or use external vent to resolve internal moisture concern.
