# ***Black Hills Inspection Services***

**Confidential - Property Inspection Report - Confidential**

Mountain Setting Road, Black Hills Area, SD  
Inspection prepared for: Pre Certified by Seller  
Date of Inspection: 4/14/2015  
Age of Home: 2009

This is a general home inspection for real estate transaction purposes.

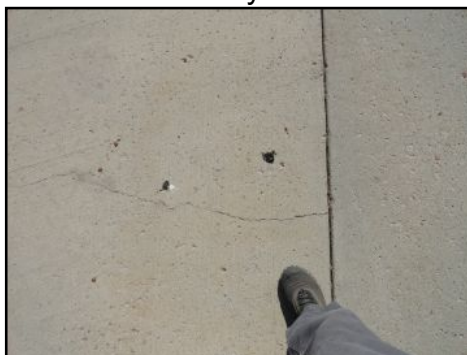
Driveway is sealed at garage interface. Good.

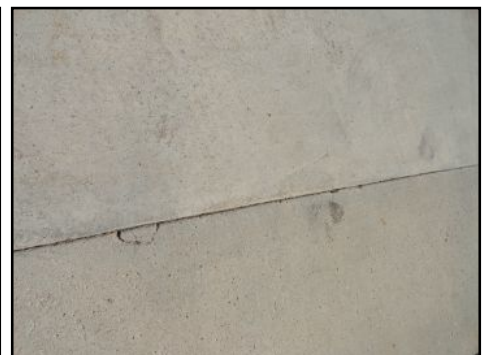
A few minor curing cracks at drive.

Cracks, gaps and chips can be sealed with a flexible caulk.

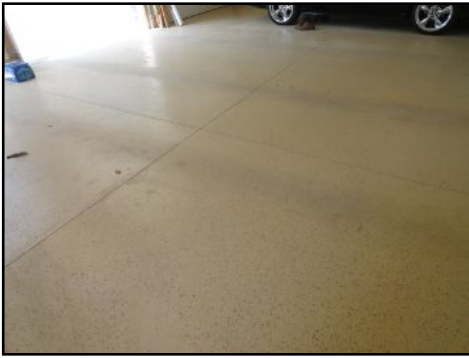
Finished garage floor. No cracks observed, kirfed expansion joints (good).

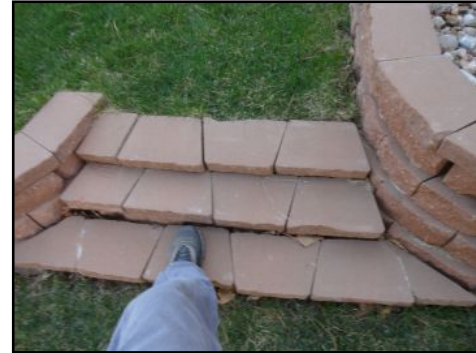
- Walkways generally appear in serviceable condition, unless otherwise noted.
- Block steps at back found somewhat loose.

A few loose steps here.

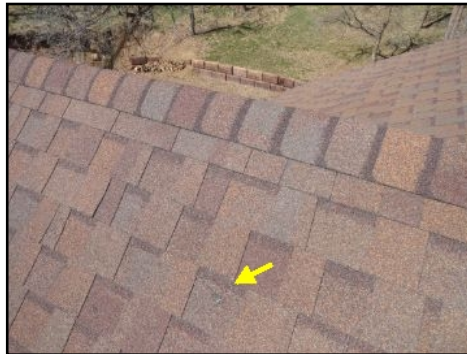
Only a few minor abrasions observed.

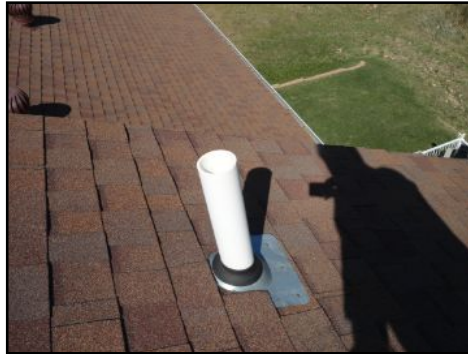
Plumbing vents were properly flashed.

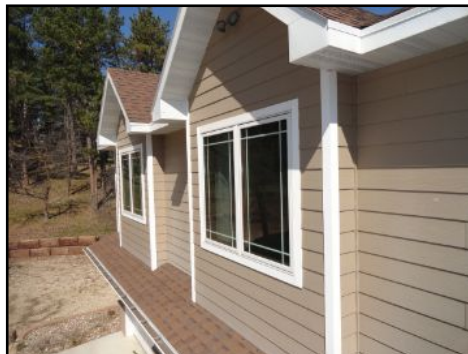
Adding gutter(s) to this top profile would be an improvement, but no present concern with shingles below.

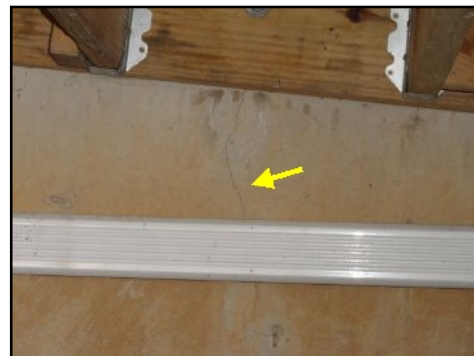
Curing cracks such as this are somewhat common and should not prove a problem.

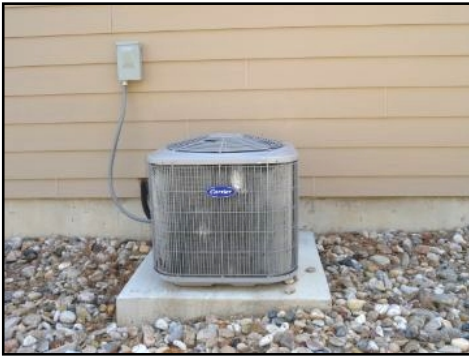
A few significant hail impacts observed on this north wing A/C compressor.

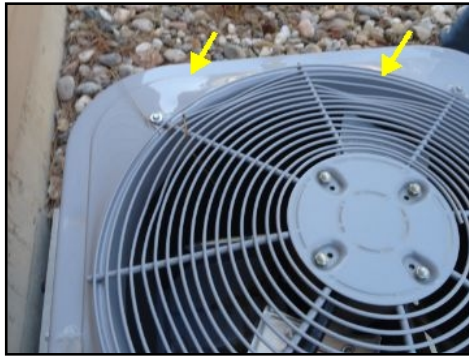
Impact areas.
