# ***Black Hills Inspection Services***

**Confidential - Property Inspection Report - Confidential**

#1 Best Chance Pl., Northern Hills, SD  
Inspection prepared for: R & S Homebeyer  
Real Estate Agent: Private Sale -

Date of Inspection: 10/7/2011 Time: 10:30-2:30

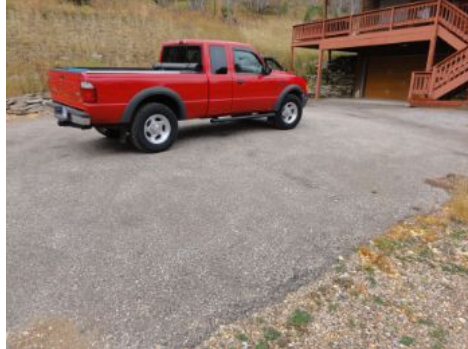
Asphalt driveway is fully functional, no present concerns.

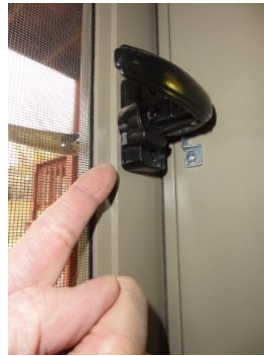
Could not unlock screen door. Check with seller about this.

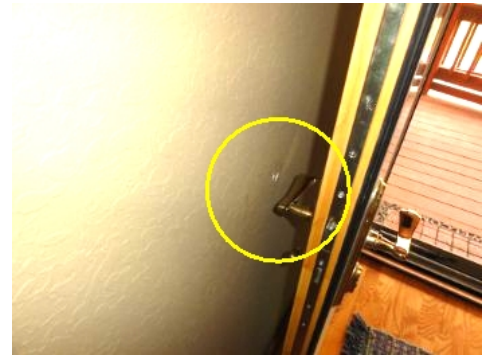
Front entry door needs a door stop.

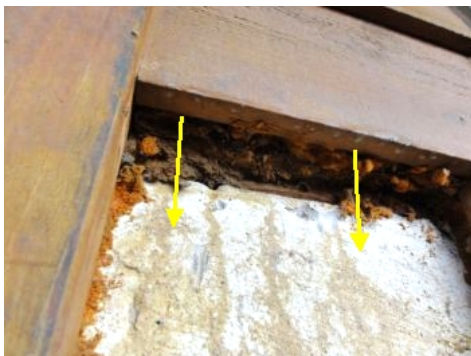
Extend siding or flash to protect sill plate.

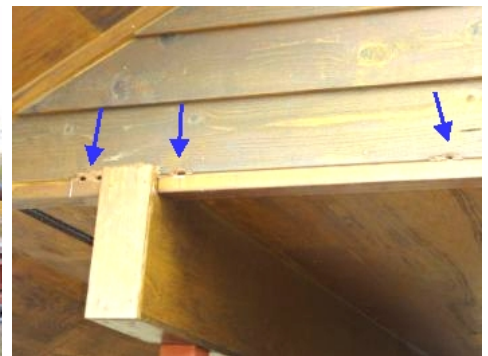
Construction bee activity observed. Putty holes to seal.

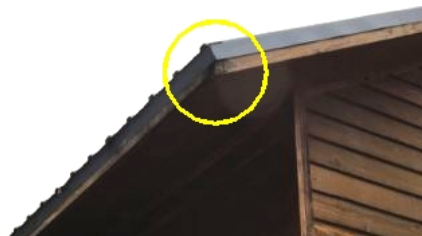
Fascia area showing wear. Monitor, some maintenance needed soon.

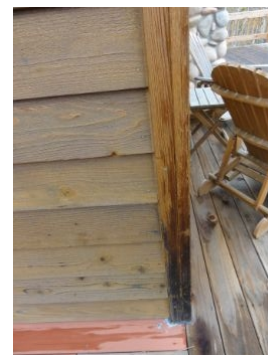
This corner trim piece is showing wear stains, sand and restrain.

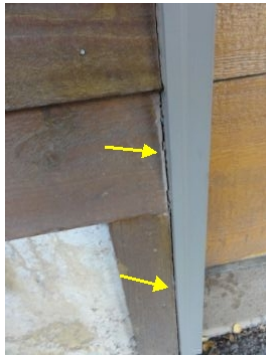
- Exterior caulking is generally in good condition except where noted. Consider caulking in drive/garage area and wear deck and siding interface shows gaps. Foam backer rod would be useful in the deck areas. Form caulk in hourglass shape.

Caulking maintenance.

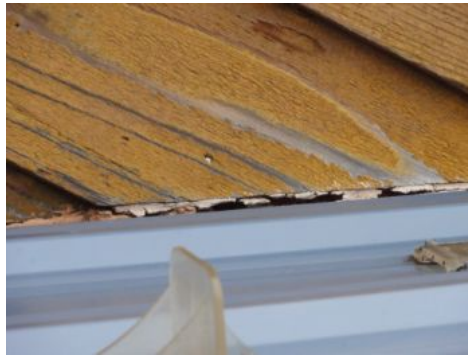
Caulking maintenance.

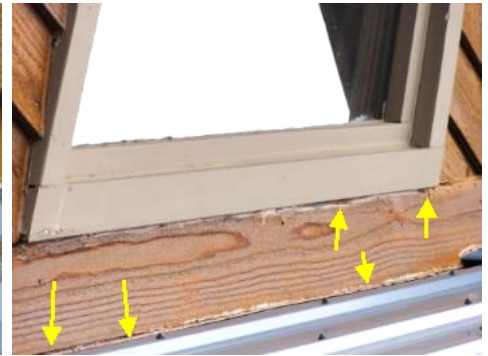
Example caulking maintenance.

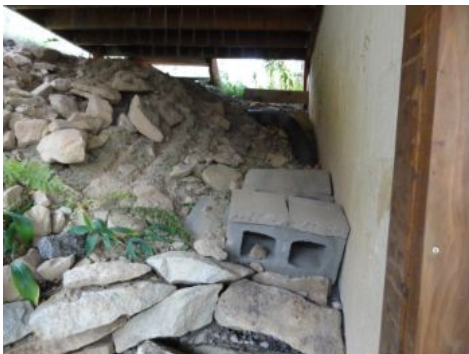
- There are some low spots along the foundation. Recommend adding additional backfill to create the proper slope away from the house to allow for effective drainage.

Consider raising grade to somehow remove drainage from wall. (consider sandbags)

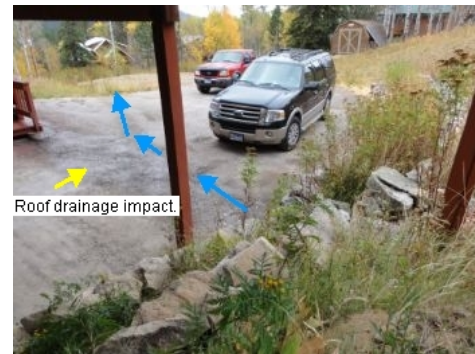
Path of hillside drainage across asphalt drive, will wear drive with time.

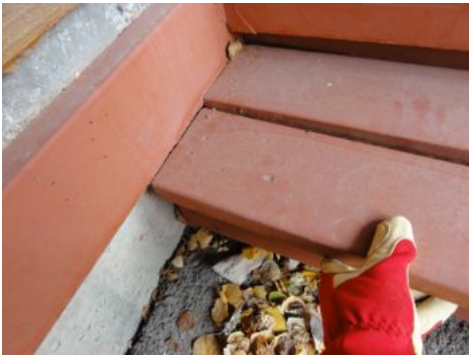
- Steps are improperly secured/installed. Potential safety hazard needs repair.

The step is loose and should be repaired. Trip hazard.

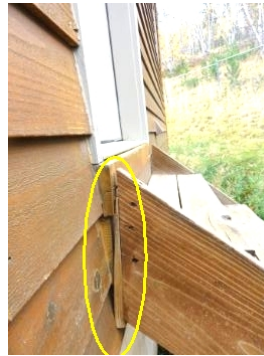
Step stringers are pulling from wall.

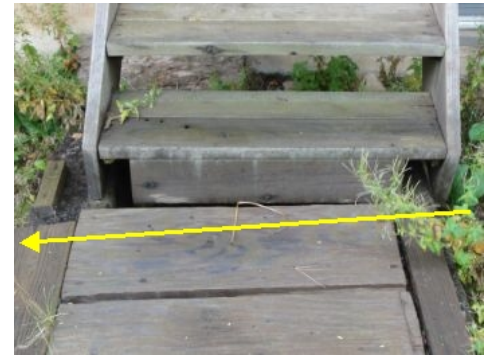
Landing is moving with erosion.

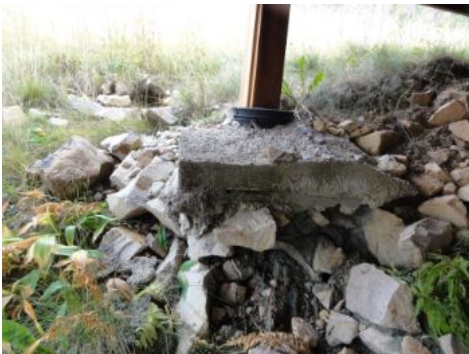
This deck pier is improperly designed, it supports jacuzzi weight.

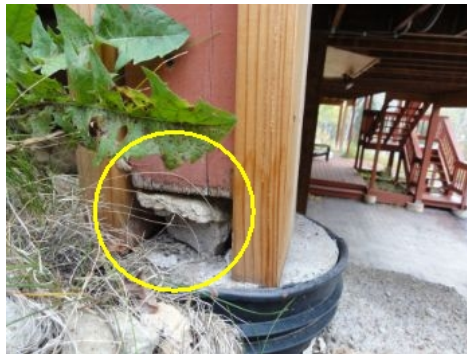
Deck pier is supported by concrete shards. This bears weight of jacuzzi/deck. The 2x's help displace load.

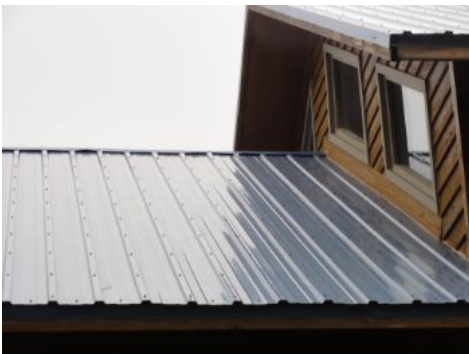
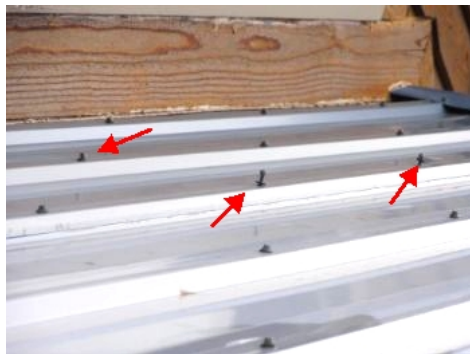
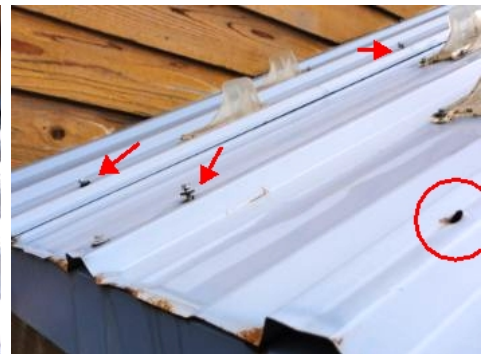
- Area of roof above the living room has several lines of screws loose, and some screws are missing. There are other areas with similar concerns on other roof planes.

Steel roof without rain trough. Water access from rain and snow melt, repair. Loose screws, missing screw, allows water access.

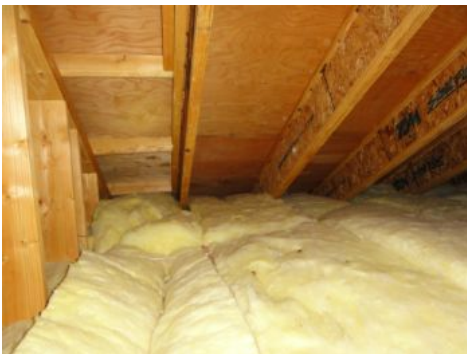
- Soffit vents were blocked by insulation. Allowing air from soffits is key in this microclimate to keep attic well vented and to prevent potential for biogrowth forming. See photos next section.

No insulation baffles at soffits block air flow.

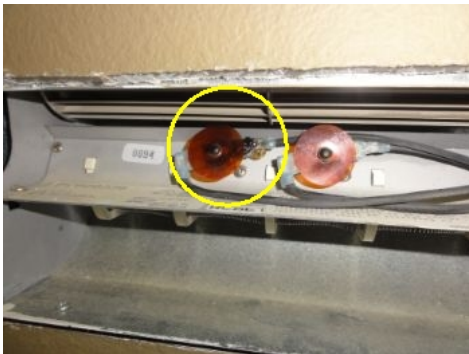
- No deficiencies observed with all but one electric wall heater.
- Wall heater in lower family room does not activate, scorching of electronic component observed. Power to pellet stove not available. Both appear in need of servicing.

Heater on right side of lower pellet stove is not operating. Signs of scorching on wiring.

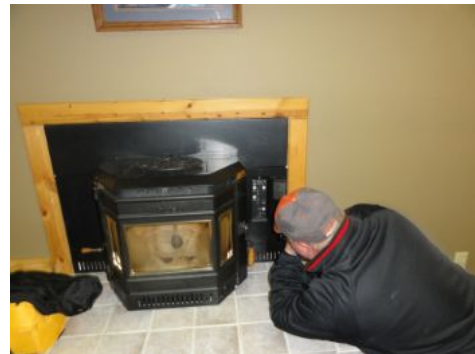
Pellet stove would not activate at controls.

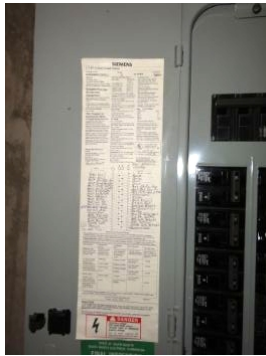
- The main panel appears to have NO room for future upgrades or additions to the system.

This panel is at full capacity.

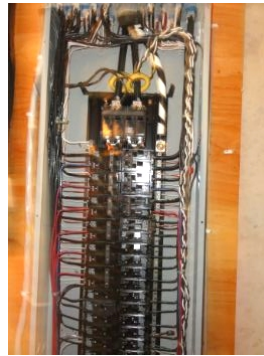
Service panel is properly wired (one breaker double tapped), is full-up (no room for expansion).

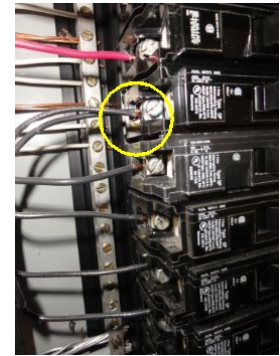
Double tapped breaker should be resolved (pigtailed).

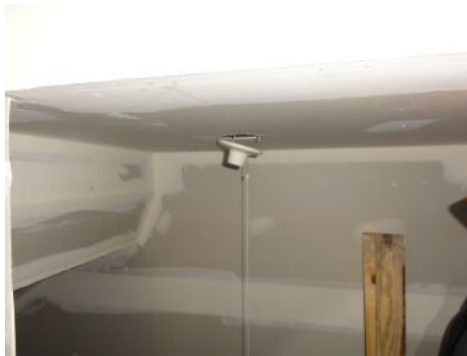
- A representative number of receptacles, switches and lights were tested and are generally serviceable, unless otherwise noted.
- Repair is needed for the utility light.

Light in utility closet needs repair.

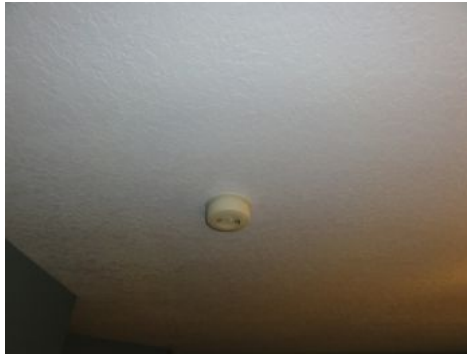
- Some smoke alarm(s) did not operate when tested. Recommend that a smoke test is performed to determine functionality, and/or need for repair/battery servicing.

Bedroom smoke detectors lights were active, but didn't respond when pressed.

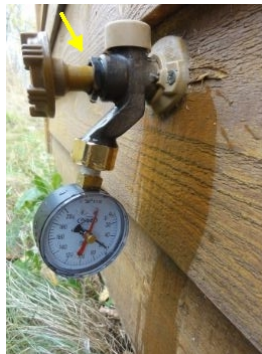
- Operated properly when tested, but showed some dripping or leakage from valve area when activated. This can usually be resolved by tightening nut as indicated.

Hydrant has some leaking at valve. Pressure is 60 psi.

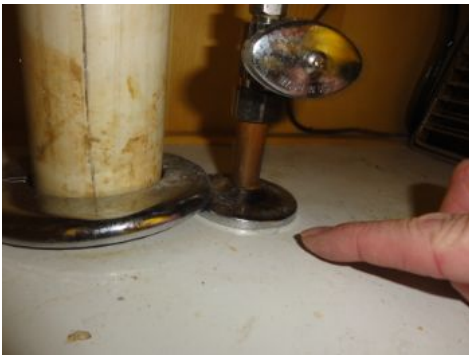
- Water valve below kitchen sink has a slight leak.

There was a slight leak under kitchen sink.

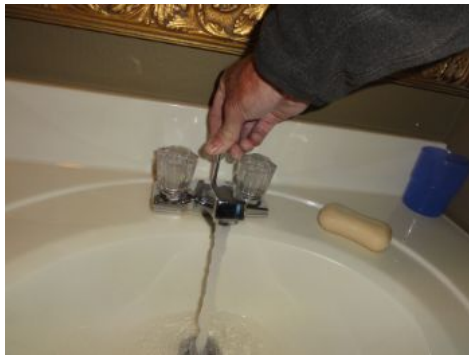
Drain stop non functional on this sink.

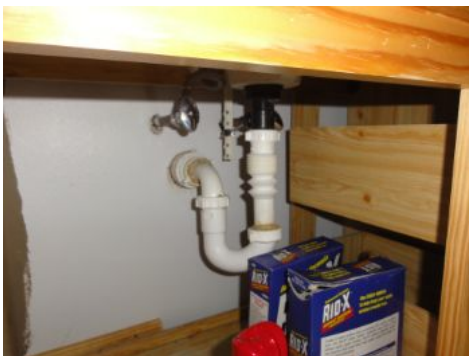
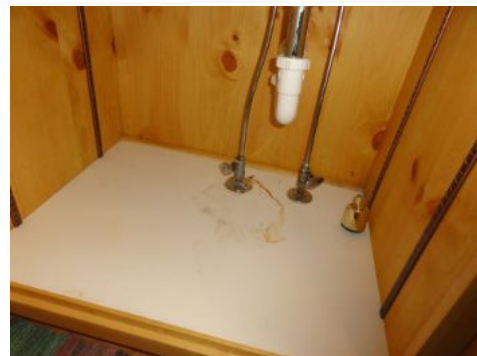
Old water stain doesn't appear active.

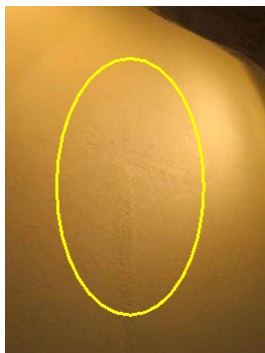
"Cross" impression above pellet stove on main level. (Positive omen?)

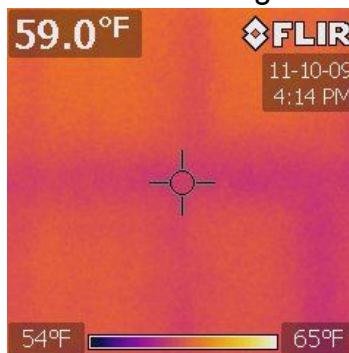
IR Analysis for moisture is inconclusive

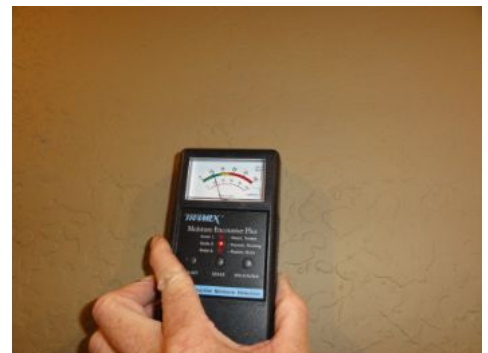
Moderate (10%) moisture content at "cross" area. Monitor this area during wet weather.

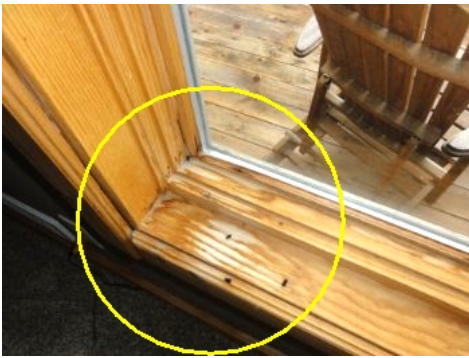
Water damage on this particular window

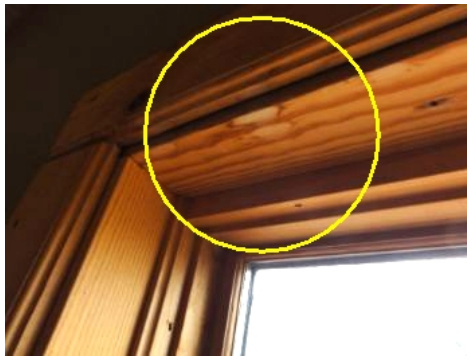
More water stain evident here.

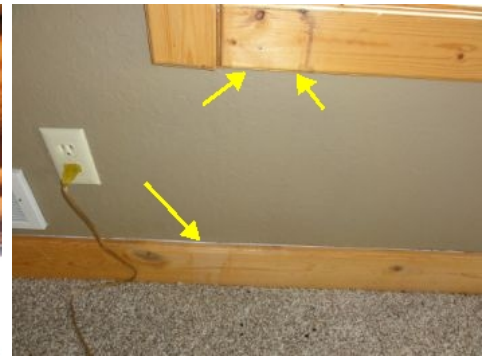
Water staining.

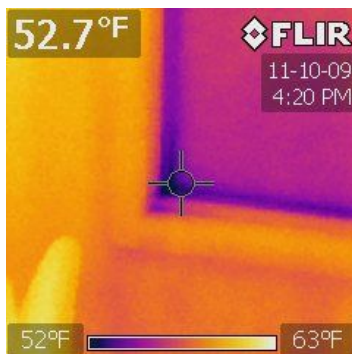
Thermographic analysis shows no present moisture signature.

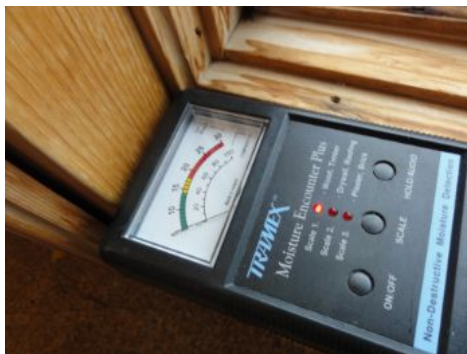
No moisture evident at stained area of window framing.

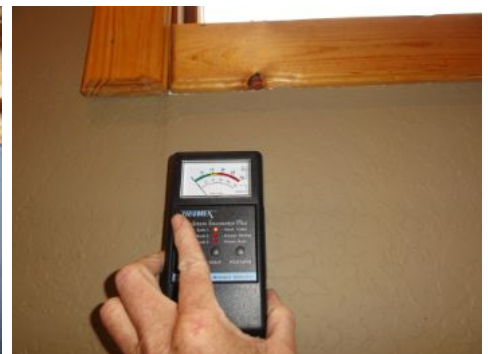
No moisture evident presently.

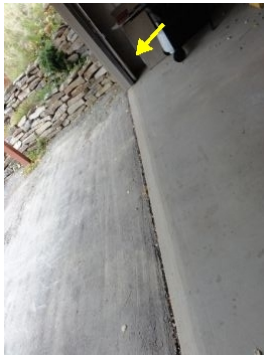
- Safety sensors were not installed normally and do not function as designed. Recommend relocating sensor to base of door where they belong.

No safety features for garage door.

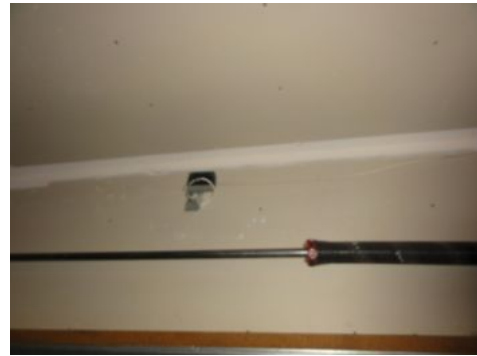
Safety feature is improperly mounted near garage ceiling, possibly for later installation.

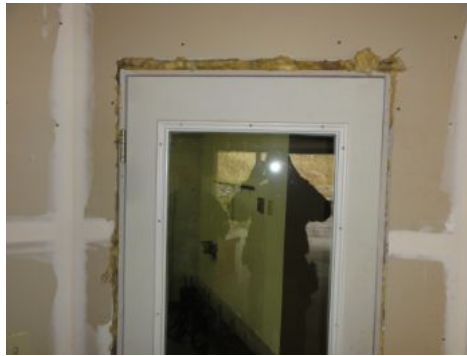
- Trim is needed at garage entry fire-door.

Add trim to garage fire door jam, to stop fire & car exhaust entry.

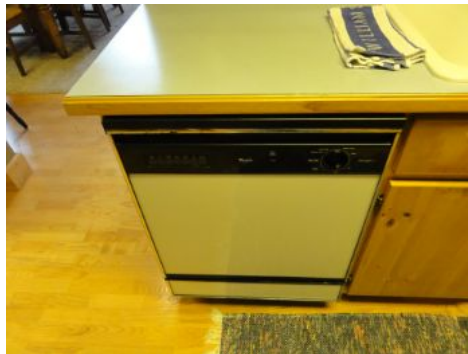
- Functioned properly but had a slight, atypical whirring sound. This is an older unit and may need replacement at some near future point.
