# ***Black Hills Inspection Services***

**Confidential - Property Inspection Report - Confidential**

3630 Hall Dr., Rapid City, SD  
Inspection prepared for: Mike Thompson  
Real Estate Agent: For Sale by Owner -

Date of Inspection: 8/25/2014  
Age of Home: 1949

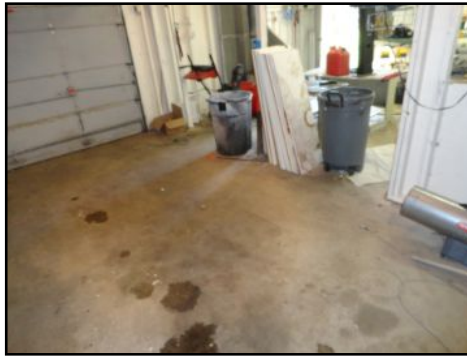
Garage floor generally in good condition. No significant cracks.

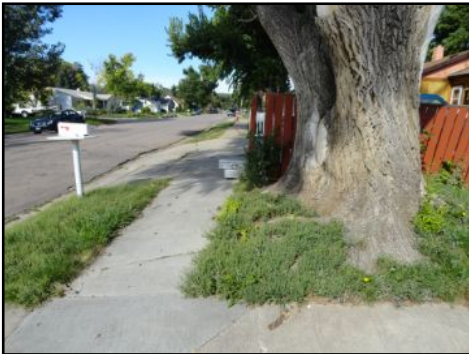
An old growth cottonwood is affecting concrete at walkway and front drive, not atypical for this area.

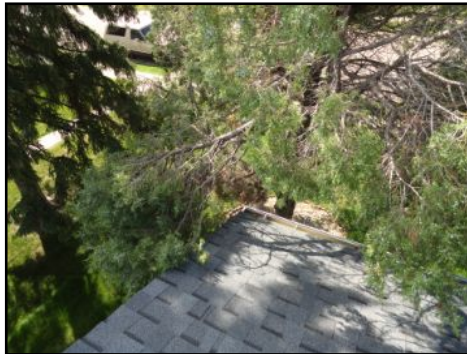
Tree/bush may cause shingle &/or siding abrasions during high winds. Trim or remove.

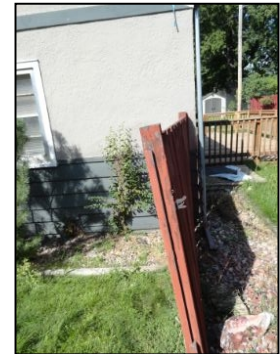
Several areas of fencing appeared wind-blown.

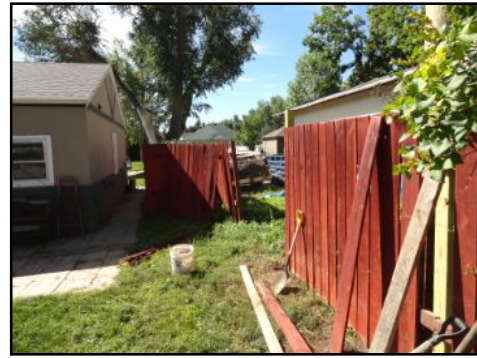
Areas of repair are needed at fencing.

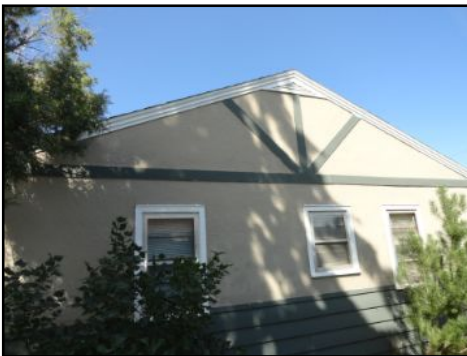
Generally well-maintained.

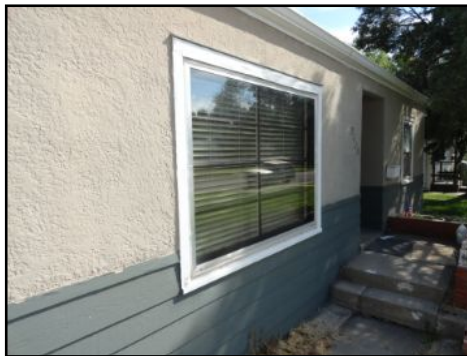
Hard coat stucco and lap siding was generally found in good condition.

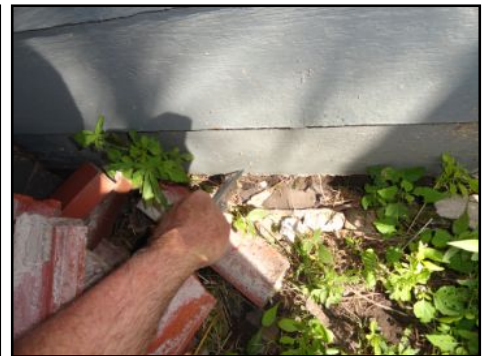
While appearing worn the bottom course of siding did not show any extensive rot, where probed.

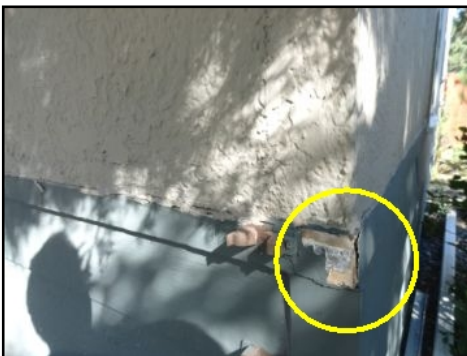
Area of maintenance improvement needed here.

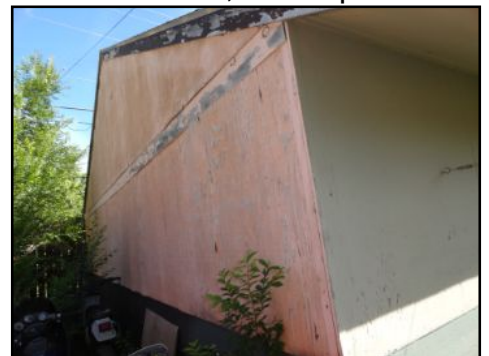
West side of garage has overdue maintenance and repairs are needed.

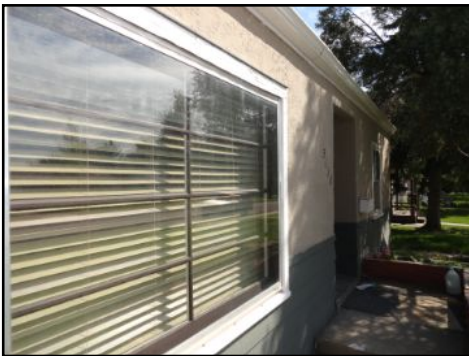
No cracks or broken glass observed at windows.

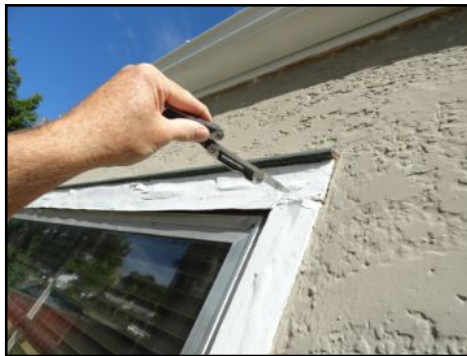
Although appearing worn in areas, no obvious rot was observed.

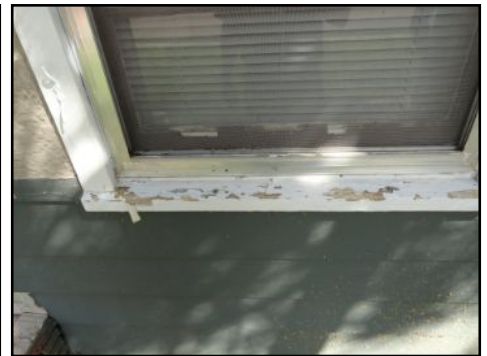
Several wood frames showed peeling paint and windows are ready for scrap/prime/paint maintenance.

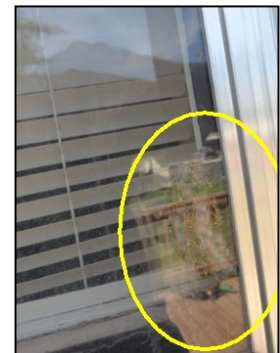
An active wasp nest was found between storm and window accessed by hole in screen.

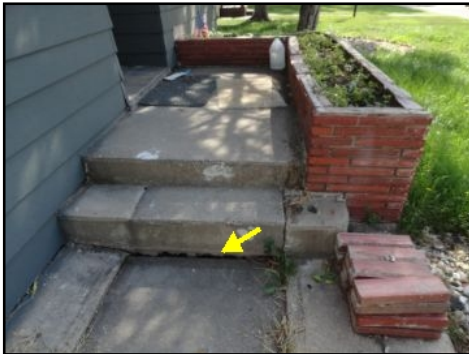
This gap at porch should also be sealed with a flexible hardscape sealant.

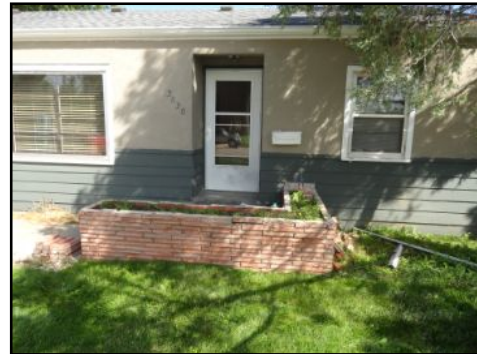
Some wear at planter including missing mortar and top level of bricks removed.

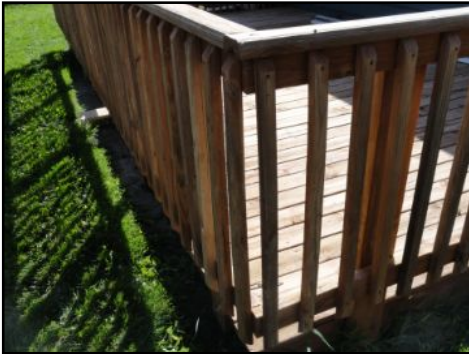
Railings appeared sound.

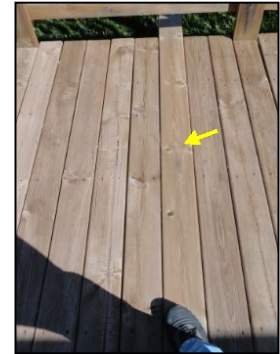
A deck plank has been replaced.

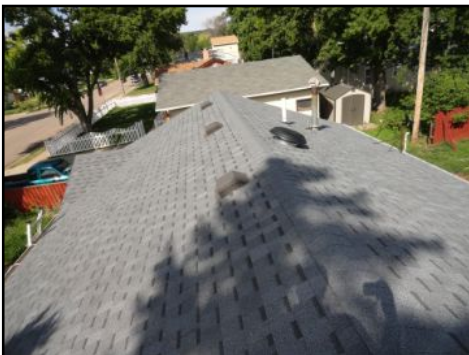
Architectural shingles have superior anti-windshear performance, are professionally installed

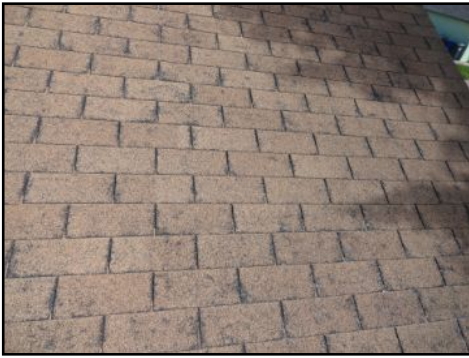
South facing shingles at garage are worn, in last phase of effective service life.

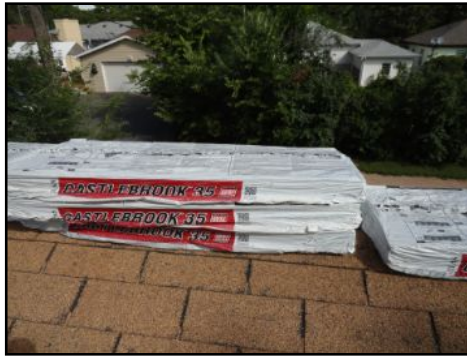
New 35 year shingles are available for garage roof. Good.

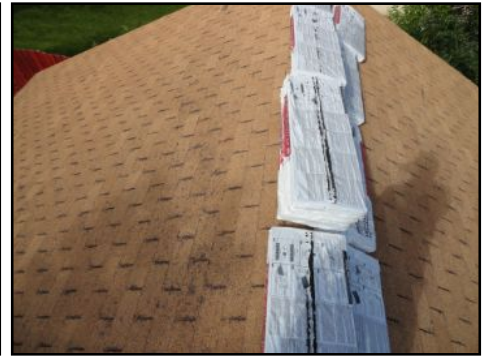
North facing plane is not as worn as south plane.

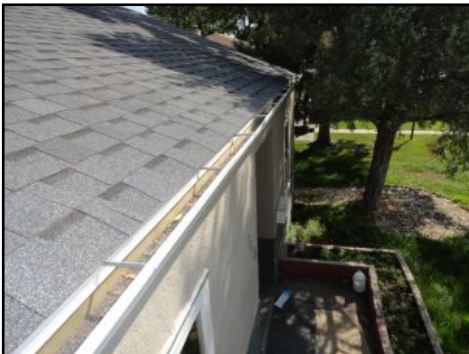
Gutters should be cleaned on annual basis.

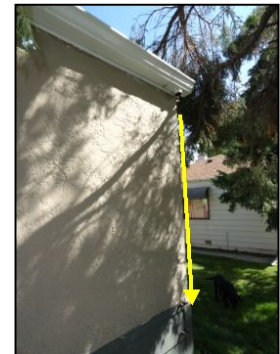
Missing downspout here.

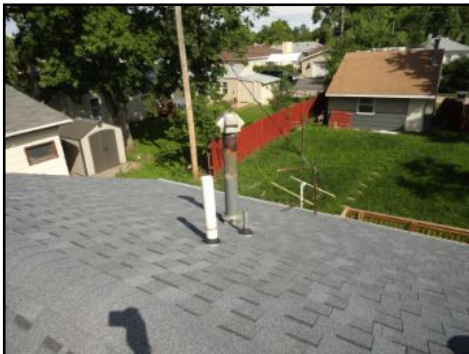
All penetrations appeared properly flashed.

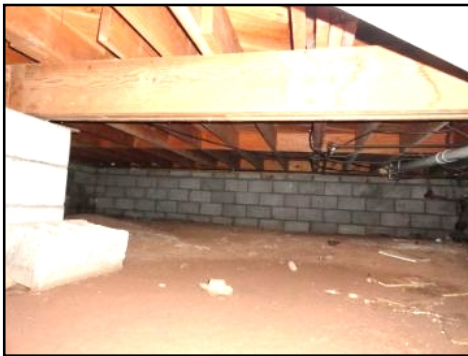
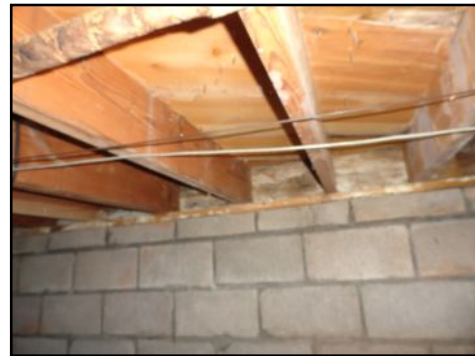
Generally foundation walls were in good condition. Due to heavy rainfalls in recent days some moisture wicking was observed. The stains on wood components near perimeter are not atypical for this era home & result typically from condensation when crawlspace is damp during colder temps.

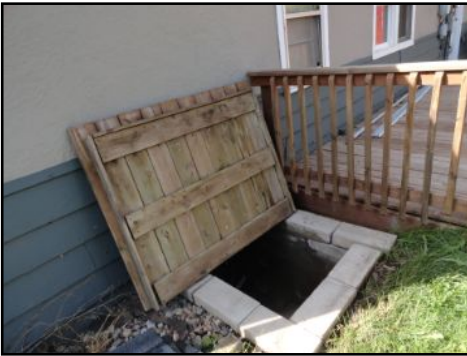
An improvement for crawlspace would be a more weathertight access hatch.

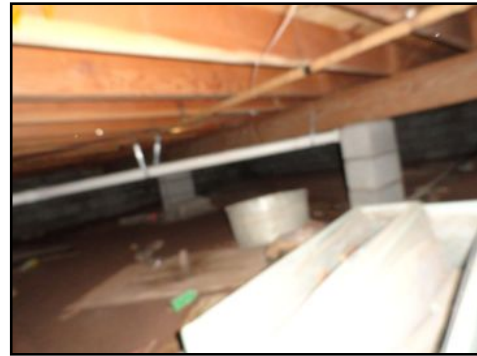
Removal of debris from crawlspace (particularly organic items such as cardboard) is recommended.

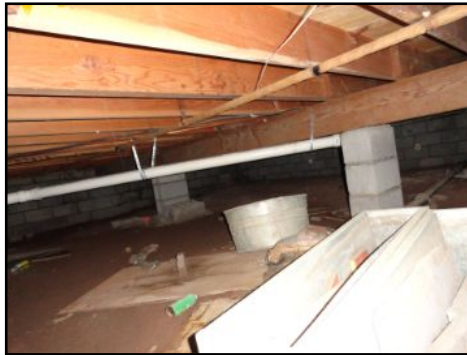
Concrete block columns support at large girder beam, common for crawlspaces.

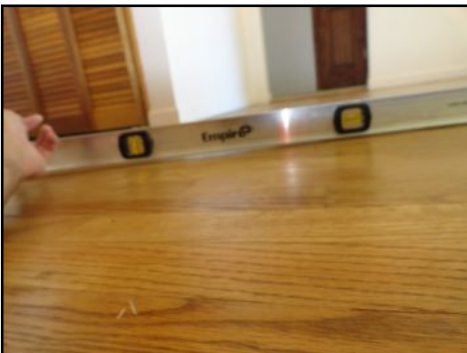
Very slight droop at floor appeared relatively inconsequential as viewed from crawlspace.

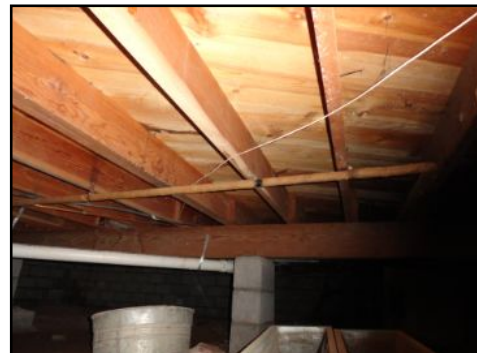
Floor structure generally appeared in good condition.

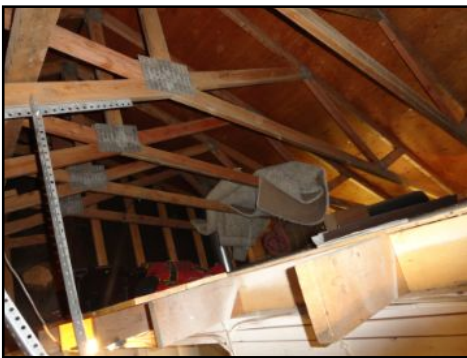
Scissor trusses found at garage roof, which would create a vaulted ceiling if finished.

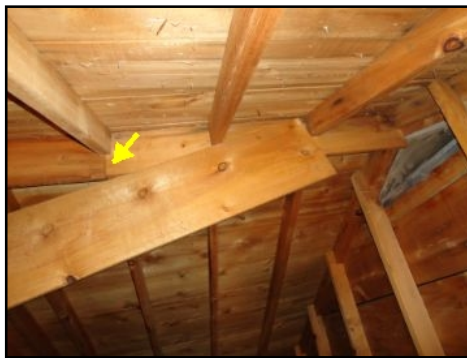
The seam at this ridgeline girder could be improved with a support post underneath.

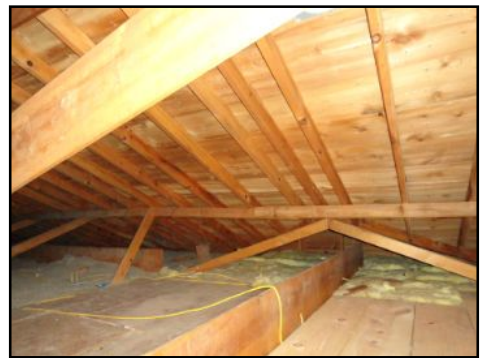
Roof structure overall in good condition for this era home. Amendments are apparent.

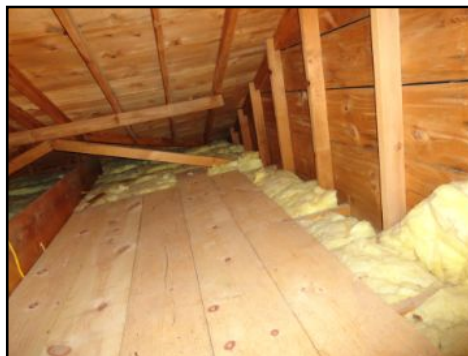
There was a storage deck at west end of attic.

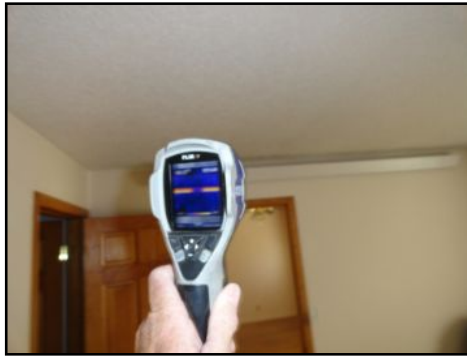
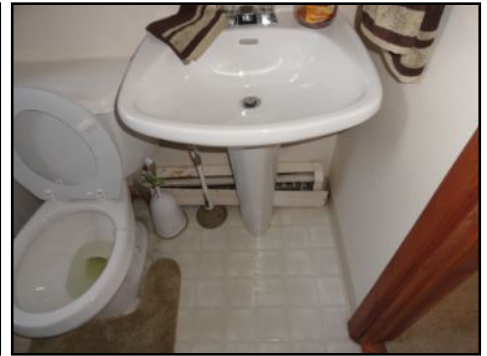
The boiler for hydronic system needs repair component to operate. Alternativley, consider upgrading to a high-efficiency on demand type boiler since plumbing appears in tact.

No heat source for the hall bath other than out of service hydronic radiator.

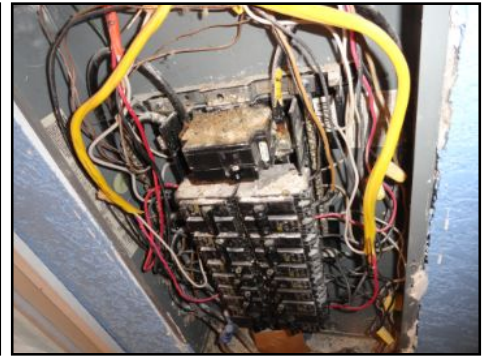
Other than particulate/debris dust, the main panel appeared properly configured. Vacuum of particulate is recommended.

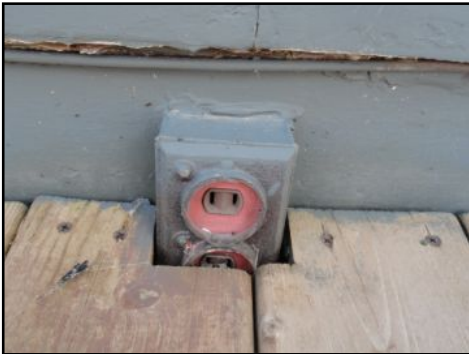
Recommend upgrading this ext. outlet to a more weatherproofed GFCI type.

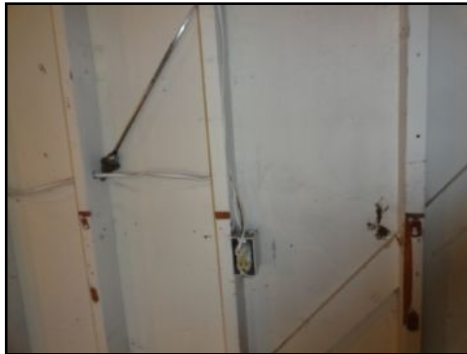
All outlets, switches and junction boxes should have proper faceplates.

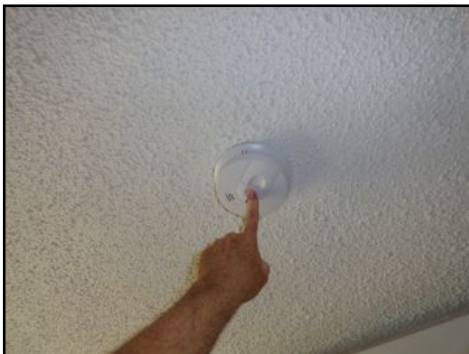
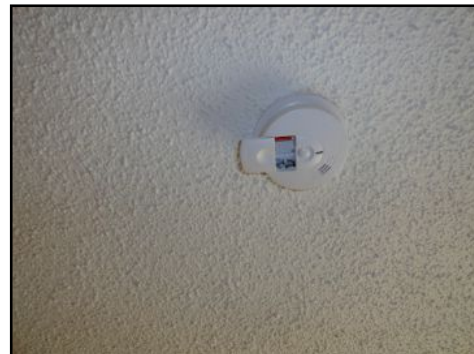
A few smoke detectors appeared to need batteries.

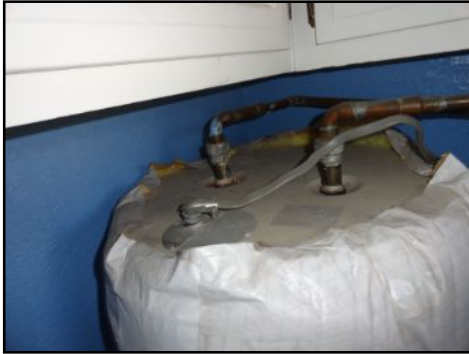
No corrosion or leaks observed at couplings.  
Expansion tank in place. Good.

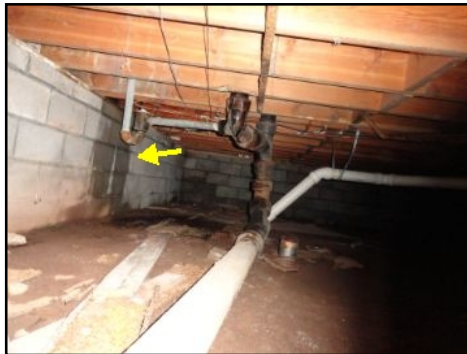
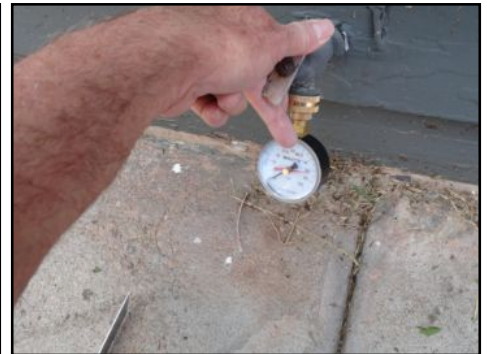
- One hydrant appeared to have a leak inside crawlspace and needs repair, the other was not functional at time of inspection. See photos.

Hydrant had no leaks at exterior (see next photo), and water pressure was ~44 psi.

There was moisture at perimeter wall near the east hydrant.

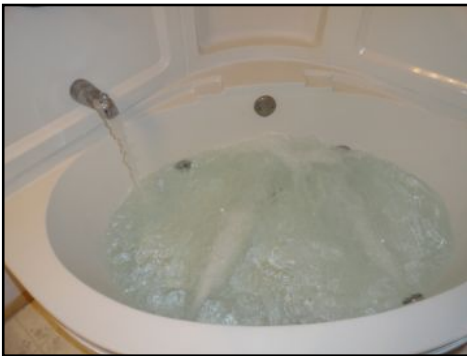
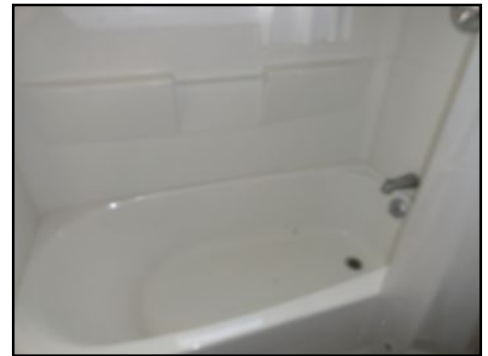
Tub needed drain cap removal in order to drain.

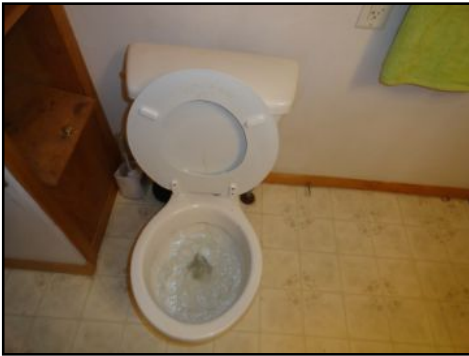
Toilet flushed properly, was not loose, did not leak.

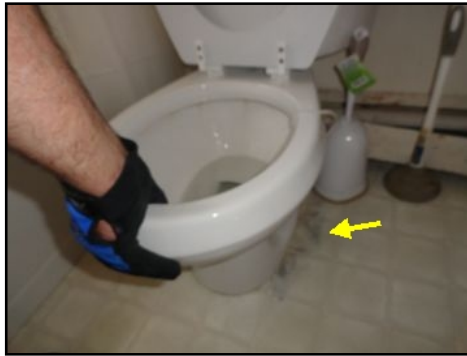
Main hall toilet was loose and needs re-installation with new wax seal.

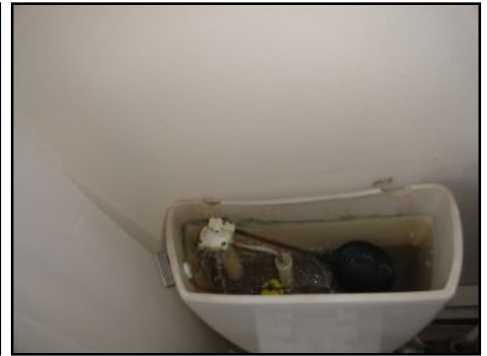
The plumbing of same toilet was not functioning properly and needs repair. Consider upgrading toilet.

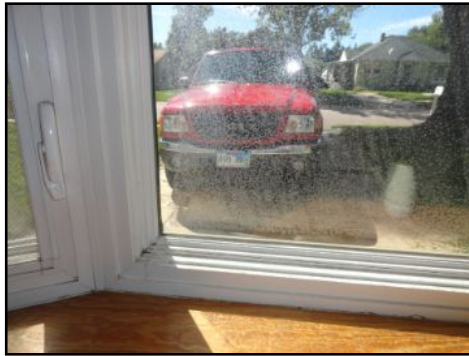
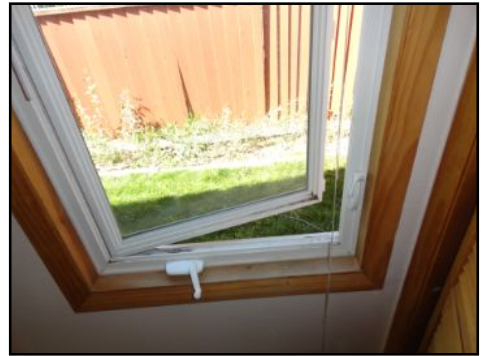
It was unclear if window had condensate between panes or if tinting was affected.

The screen for this window was resting at wall.

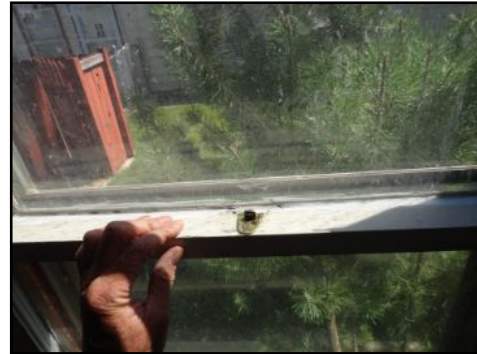
Missing fastener at this window.

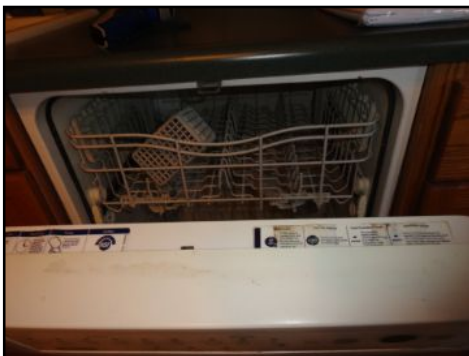
Dishwasher firmly installed.

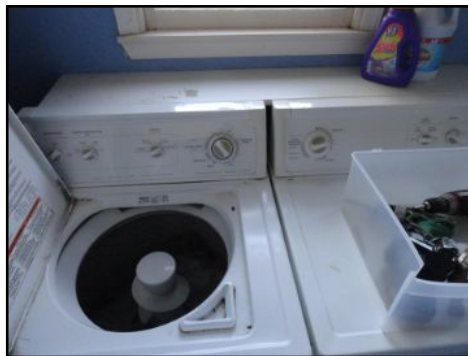
- Not tested. Clothes/personal items in machine.
- A moisture stain was observed at floor under washer. Suggest the washer be placed in a washer pan as a precaution to further staining at laminate floor.
