Black Hills Inspection Services

Confidential - Property Inspection Report - Confidential

123 Black Hills Rd., Paradise SD, 57xxx
Inspection prepared for: Sample Homeowner
Agent: Worx Forclient - Client's Preferred Real Estate

Inspection Date: 5/28/2010
Age: 11 y.o. Size: 1300 sq. ft.
Weather: Cool, Dry

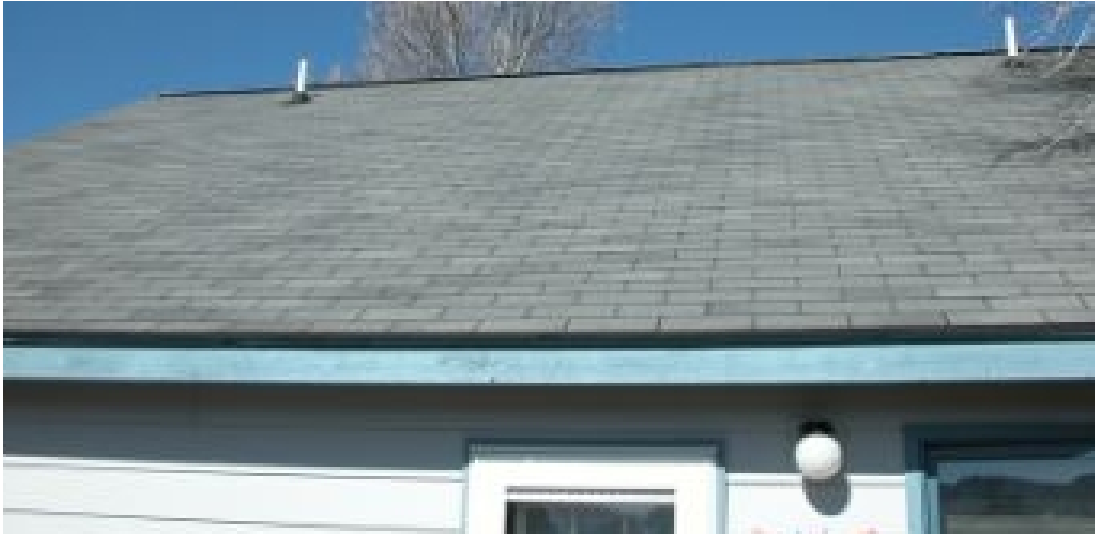
Materials: Fiberglass-based asphalt shingles

Age: 10 years • 1 visible layer observed

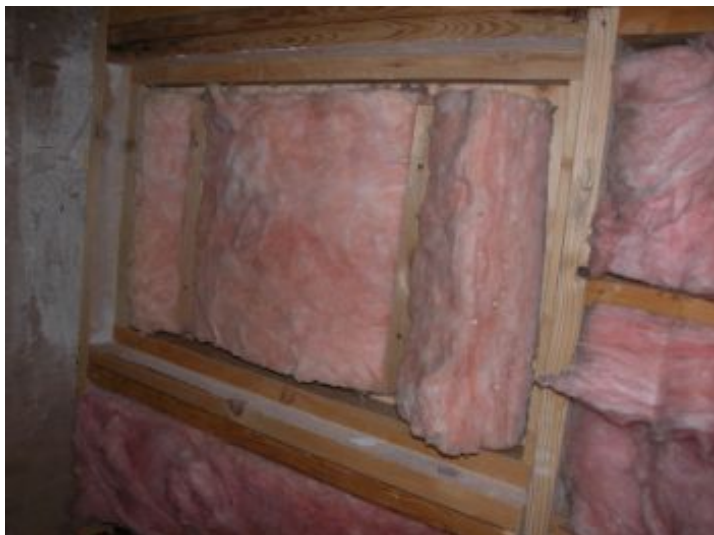
Attic and Insulation Attic Access

- Appeared functional - very well insulated, adequate ventilation and no water penetration observed. Walkway, storage-way available.
