# ***Black Hills Inspection Services***

**Confidential - Property Inspection Report - Confidential**

Mountain Setting Road, Black Hills Area, SD  
Inspection prepared for: Pre Certified by Seller  
Date of Inspection: 4/14/2015  
Age of Home: 2009

This is a general home inspection for real estate transaction purposes.

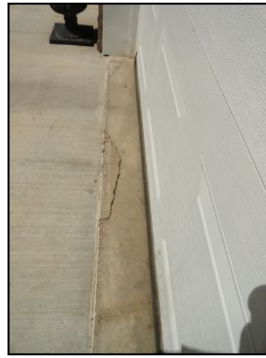
Chips and/or gaps at garage driveway interface should be kept sealed.

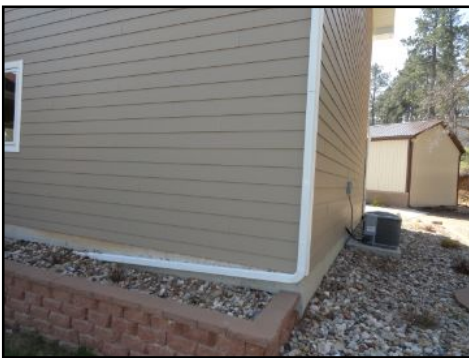
Most downspouts have subterranean drainage. Good.

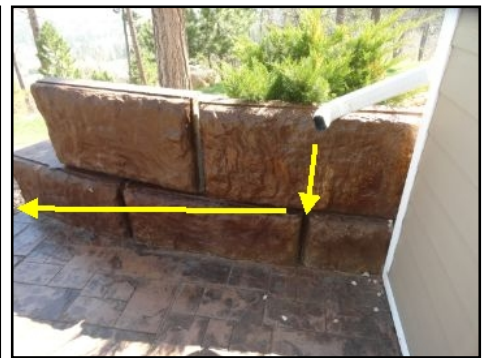
- Roof drainage downspouts should extend well-clear of foundation, and generally away from other hard surfaces such as drives, walkways, porches and patios, in order to limit underslab erosion.
- One downspout could be improved by extending beyond paver patio & behind retaining wall- see photo (it carries roof run-off for a large roof plane above).

An improvement would be to extend this downspout beyond paver patio.

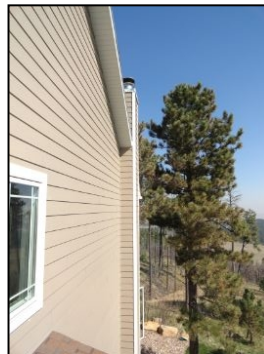
Siding is professionally installed, no significant deficiencies observed. Good

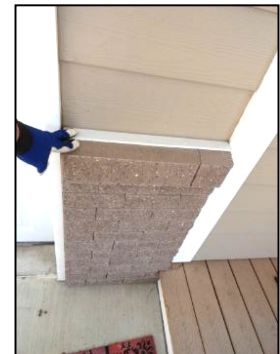
Proper flashing over block veneer.

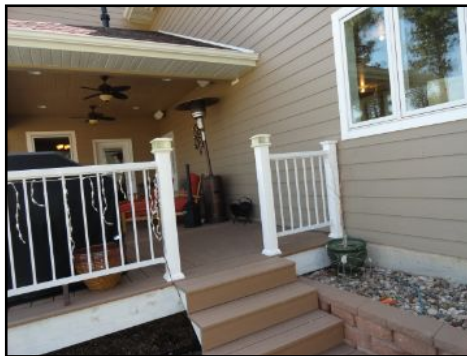
- Decks appeared in good condition and properly structured generally.
- Consider adding a handrail at steps as indicated.

Decks of more than 3 steps typically have hand rails.

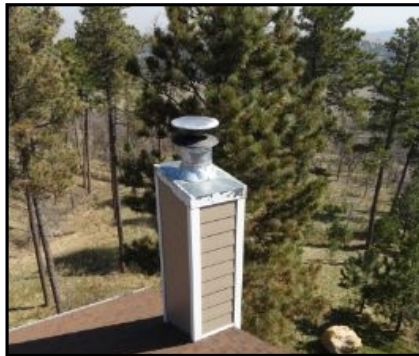
Framed chimney is properly flashed.

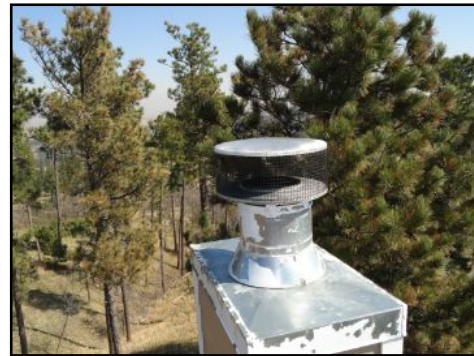
Flues appeared clean from limited view. Rain cap and spark arrestor - Good.

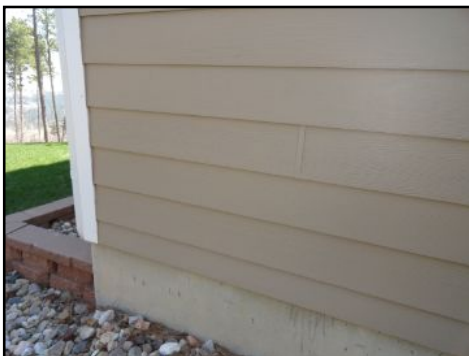
Foundation appeared in good condition where inspectable.

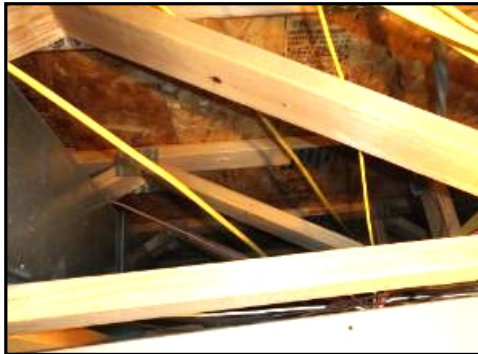
Open web trusses such as this is the premier floor structure particularly for long spans. Good.

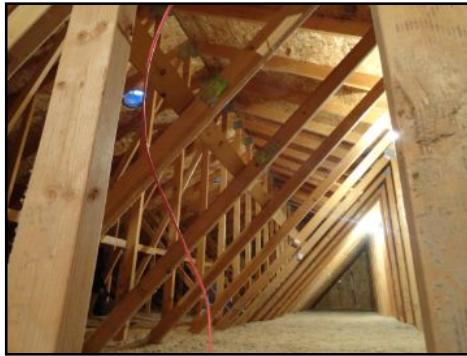
Roof structure over house.

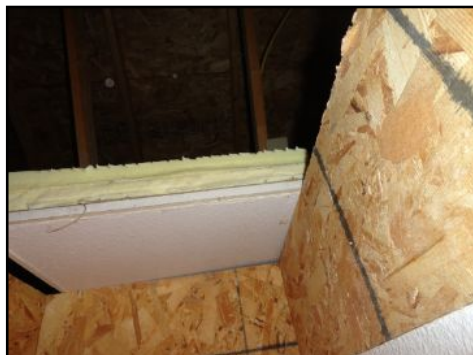
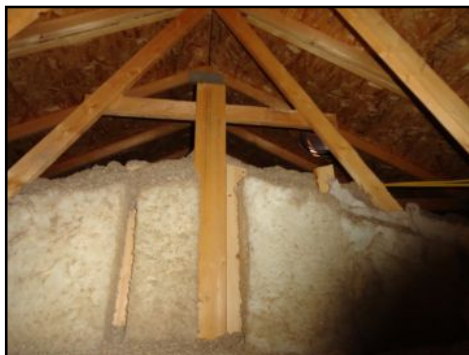
Insulated access panel. Good. Insulation at kneewalls to vaulted ceilings. Blown-in high density cellulose, ~ R-45.

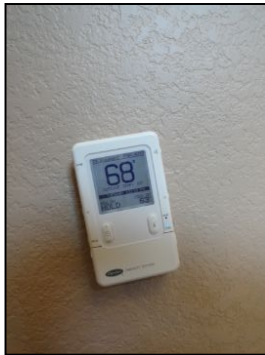
Programmable thermostats are a good energy efficiency measure.

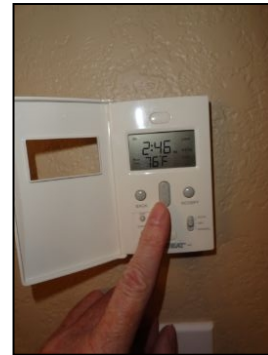
- No deficiencies noted. Furnaces & air conditioners responded rapidly and heated & cooled the home.
- No comment possible as to balance of conditioned air for various seasons is possible. See Limitations.
- Digital thermostat for radiant floor heat could not be confirmed functional. Check with seller.

Unable to activate/change settings for infloor radiant heat thermostat.

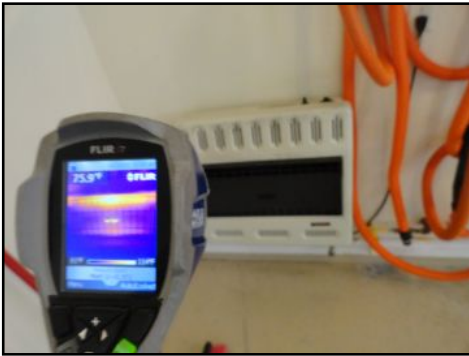
Gas furnace in garage was functional.

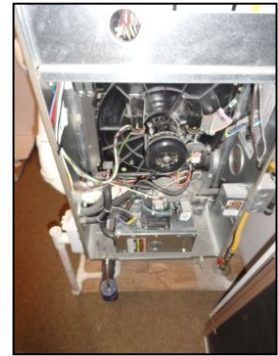
No corrosion or rust observed inside cabinet.

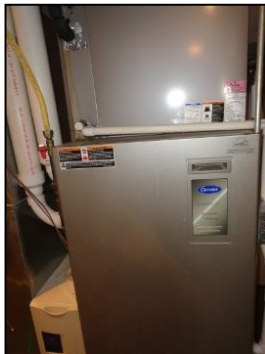
Main furnace for home.

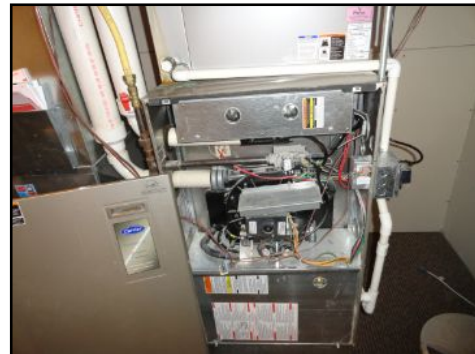
Furnace fired in proper sequence. No deficiencies observed.

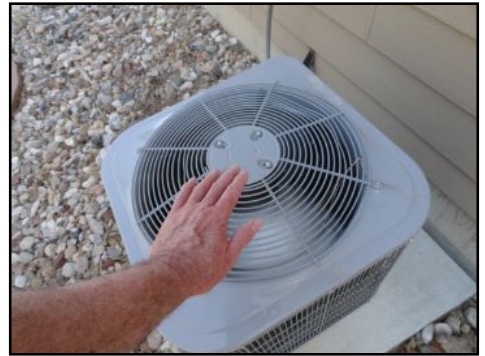
Unit was functioning properly.

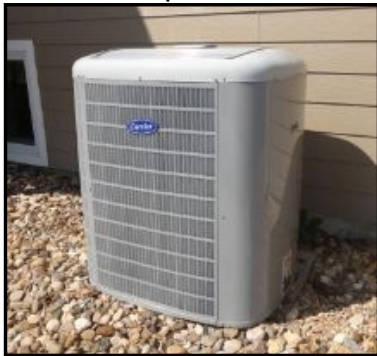
This 5 Ton system will have sufficient capacity for this volume home, if kept properly serviced & tuned.

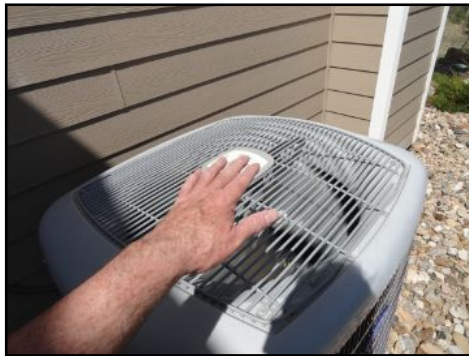
Large capacity unit also functional.

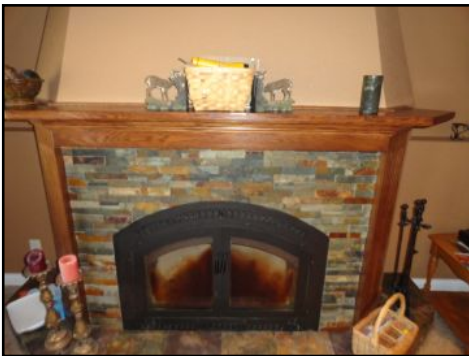
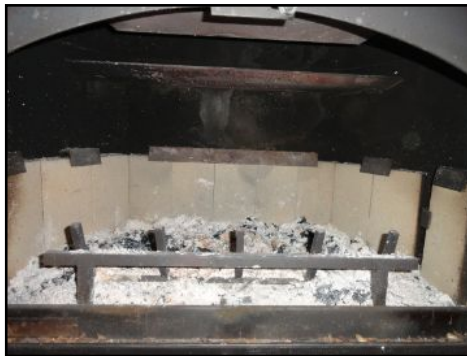
High-efficiency wood burning fireplace.

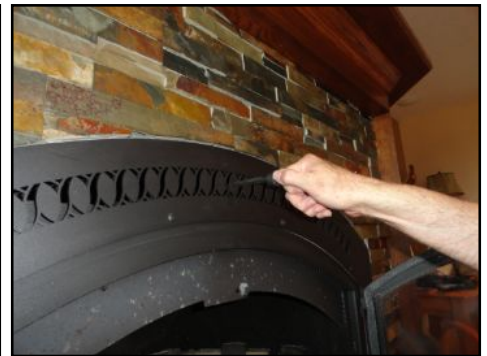
Damper was found functional.

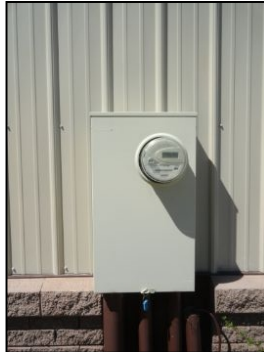
- Service drop lateral to side of outbuilding was firmly attached.

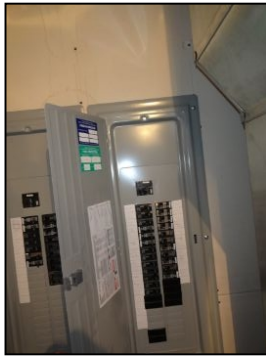
Proper inspection stickers on the dual 200 Amp main panels.

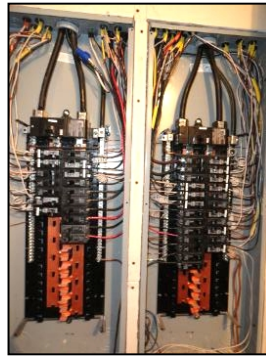
Professional installation, no discrepancies observed.

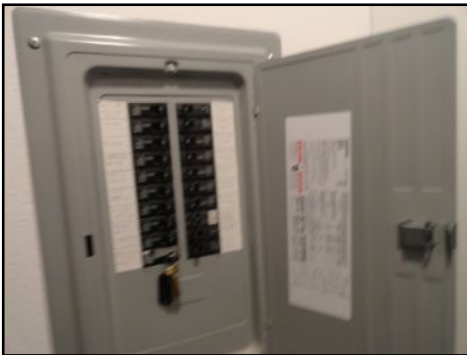
Well marked. Main breaker is at main panel.

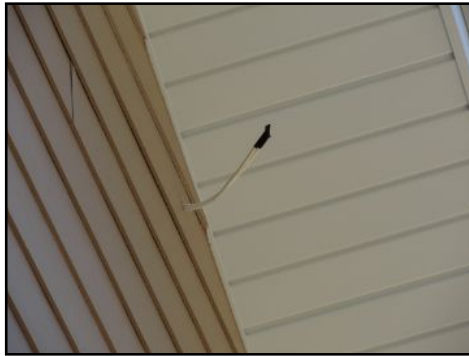
The exposed wiring here is for potential future satellite dish.

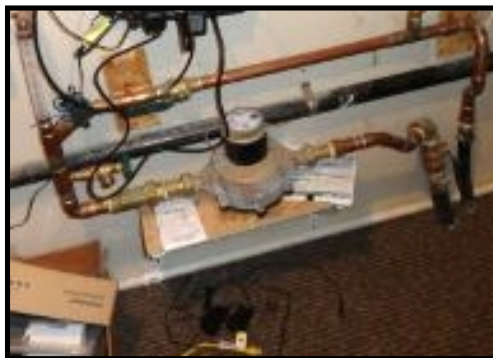
Meter and shutoff valve. Large volume 1.5" supply.

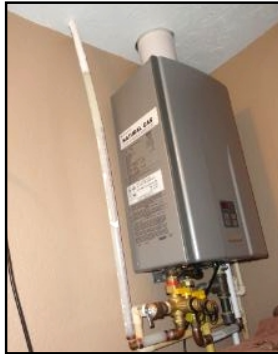
High capacity high efficiency on-demand gas boiler.

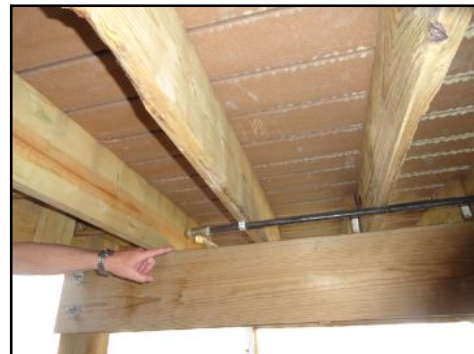
A gas line is extended under deck for potential future barbecue system.

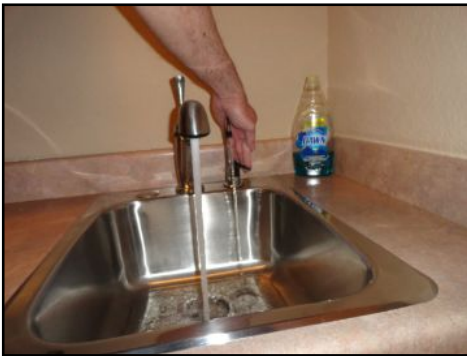
R.O. filtering system installed for drinkable water.

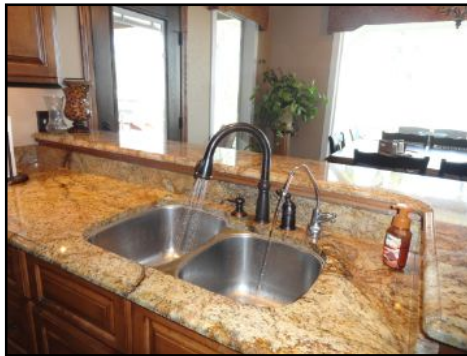
Kitchen faucet spray nozzle with R.O. water dispenser.

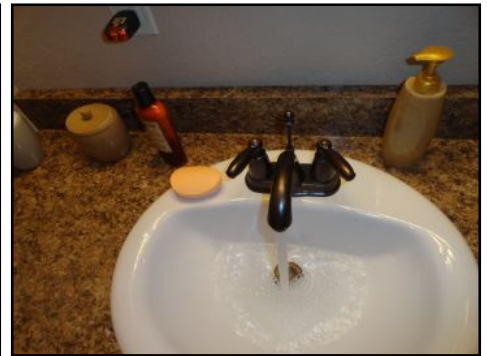
Flow was good at all faucets.

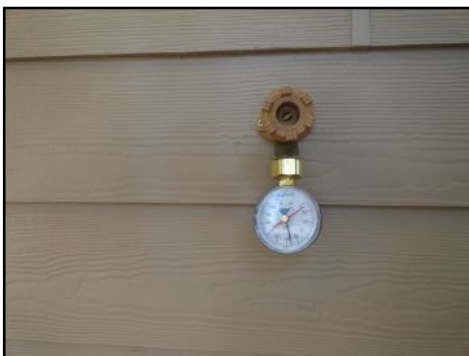
Hydrant had no leaks and water pressure was 95 psi. Good.

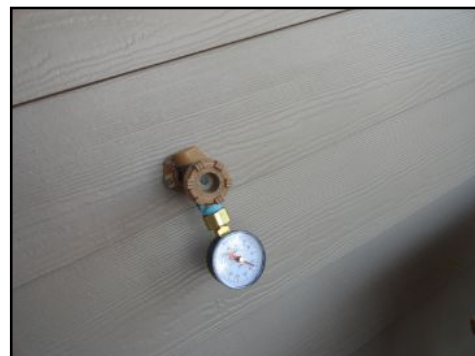
Hydrant had no leaks.

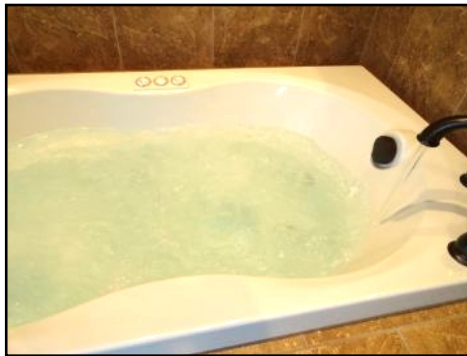
Jetted garden tub activated properly.

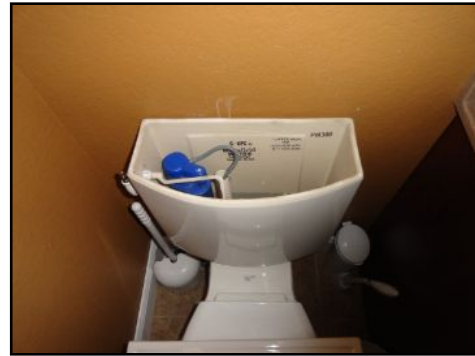
Tank looks good, no mold/mildew present.

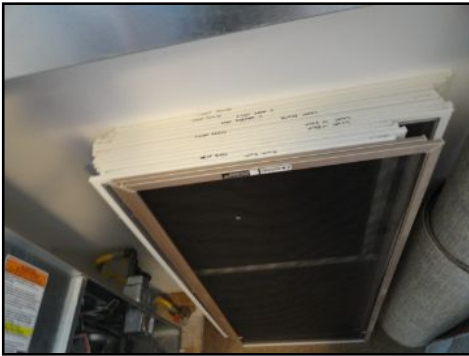
Screens for windows next to upstairs furnace unit and are labeled.

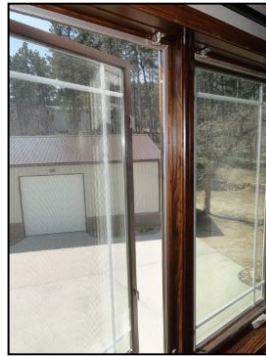
The windows appeared to function properly.

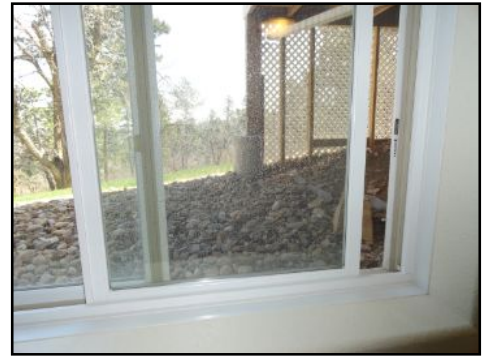
Slider at basement bedroom here.

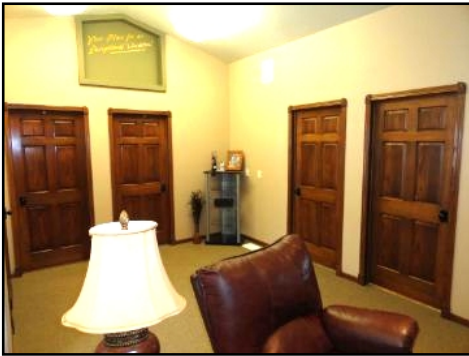
Each door closed and latched properly.

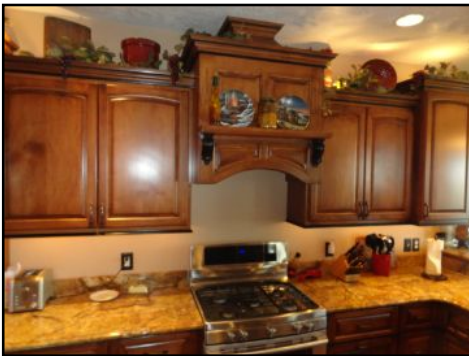
Lighted cabinets above.

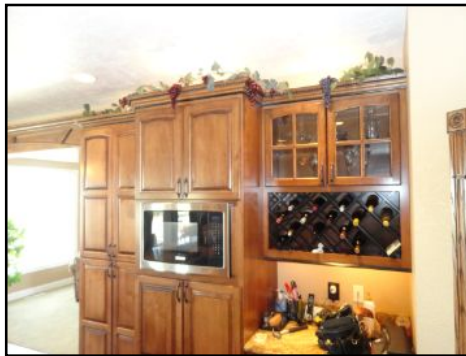
Integrated wine rack.

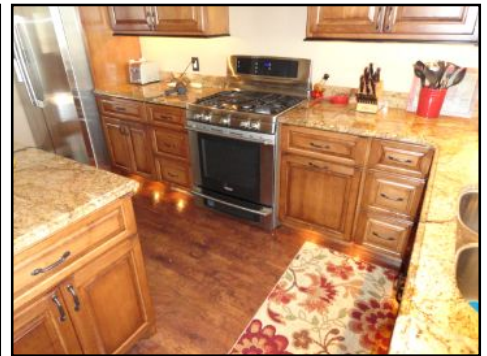
Floor lit cabinets.
