# ***Black Hills Inspection Services***

**Confidential - Property Inspection Report - Confidential**

#1 Best Chance Pl., Northern Hills, SD  
Inspection prepared for: R & S Homebeyer  
Real Estate Agent: Private Sale -

Date of Inspection: 10/7/2011 Time: 10:30-2:30

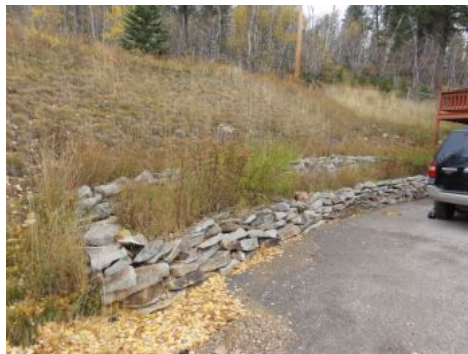
Observations: Retaining wall provides some erosion and drainage control.

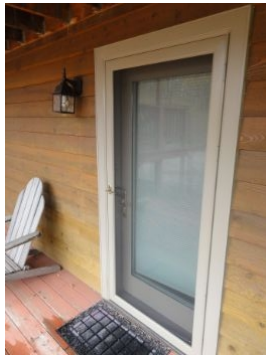
- Appeared in functional and in satisfactory condition, at time of inspection. Very high end doors, seal well (generally), and have insulation properties.
  - Could not determine how lower screen door locked/unlocked. Check with homeowner.
- Rear door needs some maintenance repair of weather seal. Doors need door-stops.

High Quality entry doors with insulated glass.

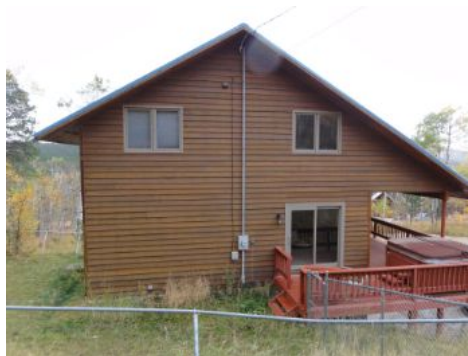
Wood plank siding has been well-maintained.

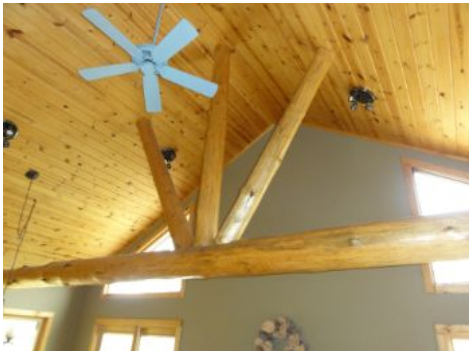
Log truss system in living area cathedral ceiling.

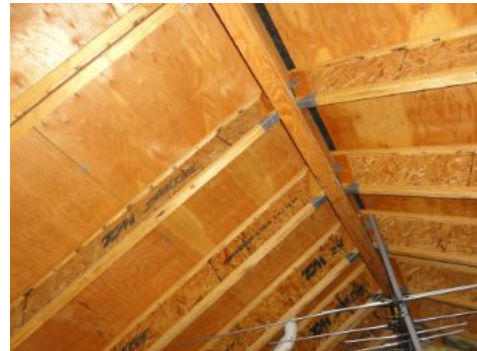
Engineered I beam truss system here. No signs of moisture intrusion.

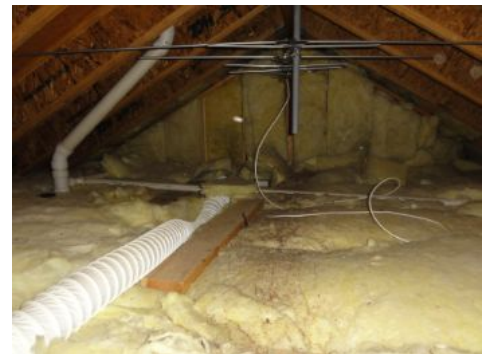
Well-insulated attic where observable.

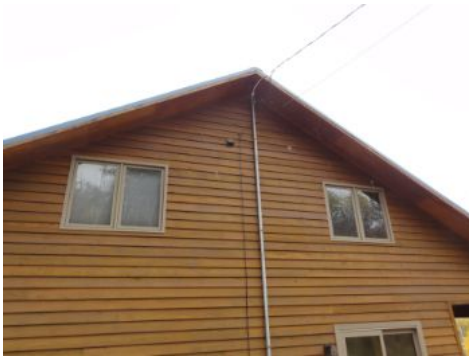
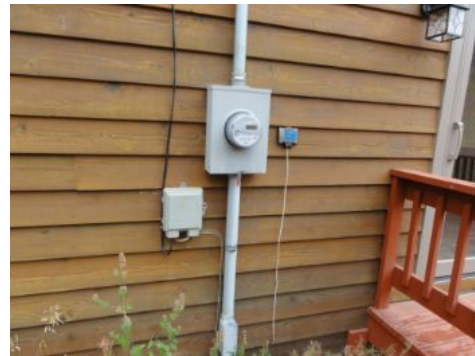
- The service drop was in particular good condition, with proper drip loop, clearance and sturdy installation.

Meter is firmly attached.

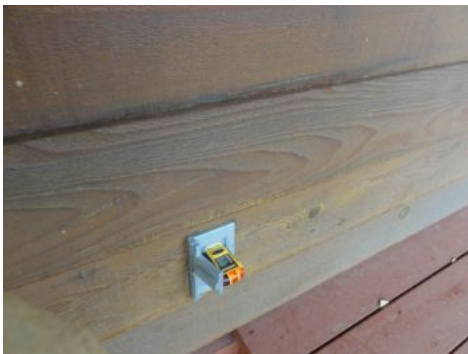
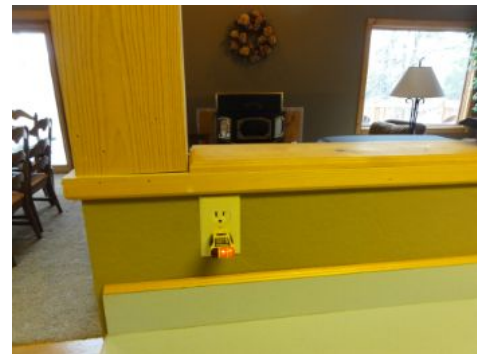
- Test GFCIs monthly to ensure proper operation.
- Operated when tested.

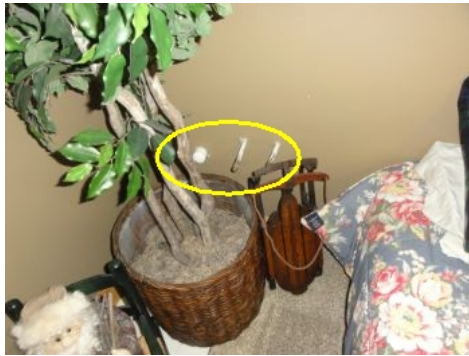
Den is plumbed for wetbar/sink.

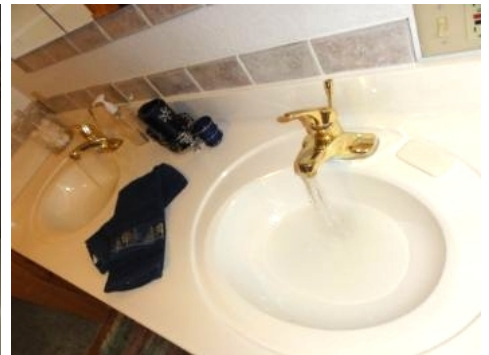
Sinks show functional flow.

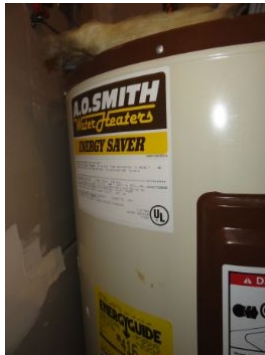
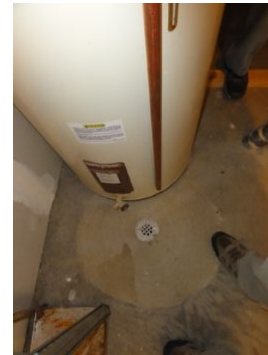
- This system is located in the plumbing closet in garage.
- No deficiencies noted with the Temperature Pressure Relief (TPR) valve and discharge pipe.

Large water heater seems to be in good shape.  
Proper drain for TPR valve.

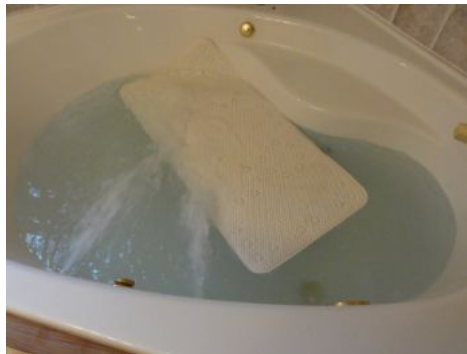
Jacuzzi tub operated functionally.

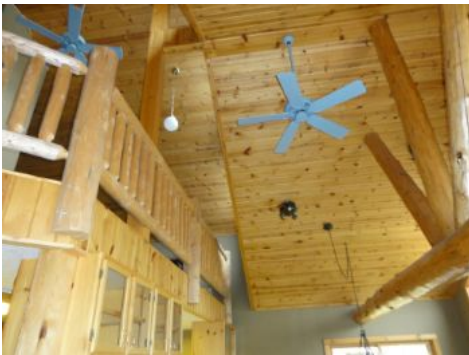
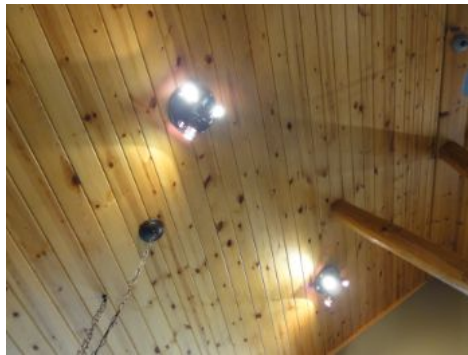
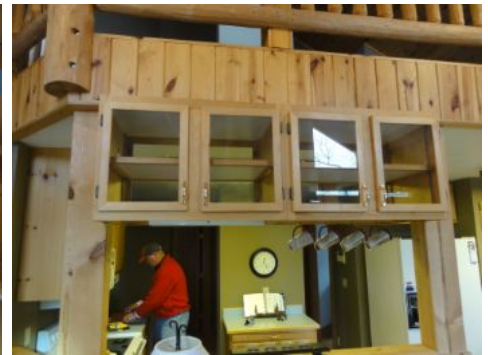
- General condition of walls and ceilings appeared good.
- Some cosmetic, common small cracks and typical flaws in drywall finish noted. This is normal wear for age of home.
- Above upstairs pellet stove sheetrock seams are evident and form an cross-like impression 2' horizontal by 3' vertical. This may be from original build, or from past or present moisture penetration. No active moisture concern was observed. Check with seller for any knowledge of past concerns for this area.

T&G knotty pine planks at vaulted ceilings.

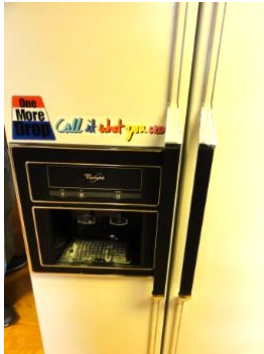
Ice maker functional
