# ***Black Hills Inspection Services***

**Confidential - Property Inspection Report - Confidential**

3630 Hall Dr., Rapid City, SD  
Inspection prepared for: Mike Thompson  
Real Estate Agent: For Sale by Owner -

Date of Inspection: 8/25/2014  
Age of Home: 1949

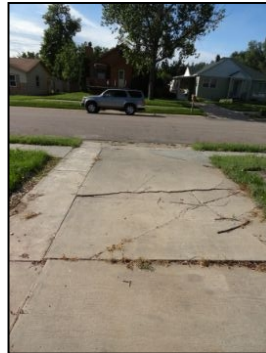
- Driveway at front now used principally for guest parking, appeared stable but showed obvious cracking. The cracks principally appear a result of a very large cottonwood tree causing uplift, so repair may not prove most effective. Recommend the cracks are sealed with a flexible caulk.
- Extensive parking and garage access is available at rear of lot via the alley.

While stable the drive shows significant cracking (particularly due to large cottonwood tree). Recommend sealing cracks to prolong effective service life.

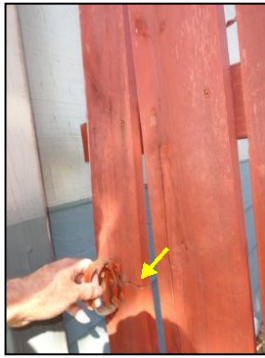
Broken plank at this handle.

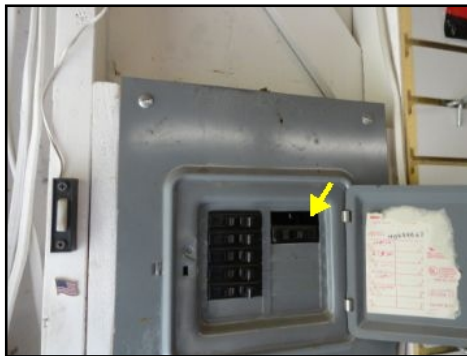
Spacer needed for open slot.

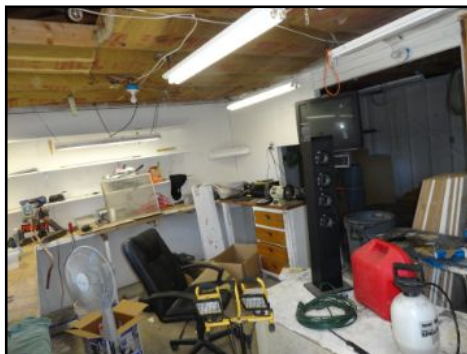
- Visible wiring appeared functional at house. Garage wiring is randomly applied in some areas and could be improved.

Some wiring in garage appeared somewhat randomly applied.

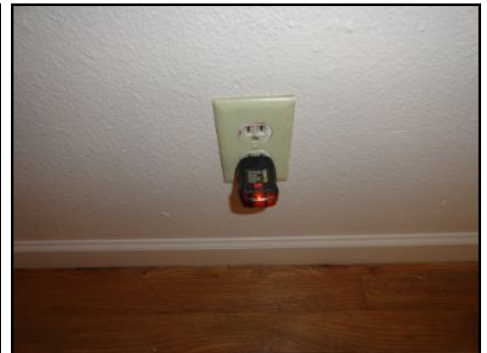
Ungrounded outlet.

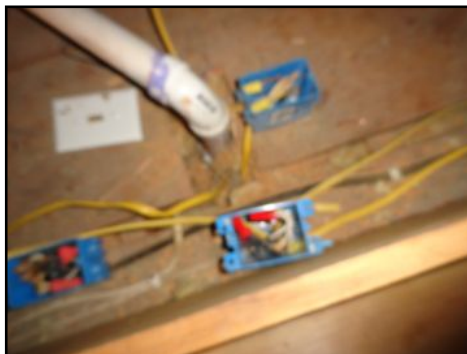
Even junction boxes in attic ideally should have faceplates.

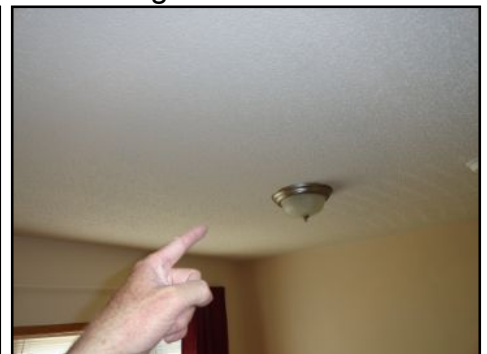
Could not activate this light, possibly needs new bulb?

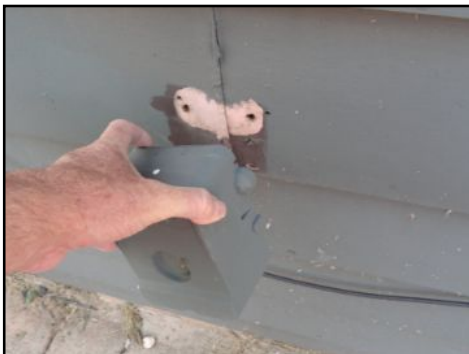
The water meter box should be more firmly fastened.

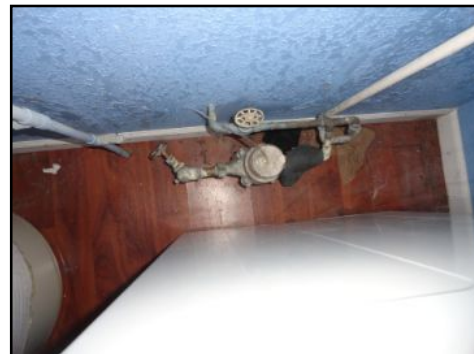
Meter and shutoff valve.

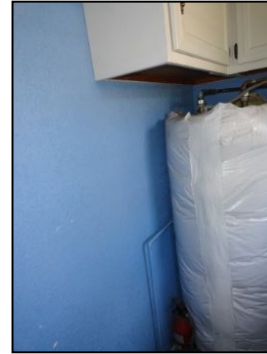
Due to insulation wrap, little could be observed at  
water heater.

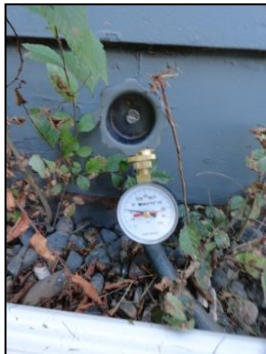
- One hydrant appeared to have a leak inside crawlspace and needs repair, the other was not functional at time of inspection. See photos.

Hydrant had no leaks at exterior (see next photo), and water pressure was ~44 psi.

There was moisture at perimeter wall near the east hydrant.

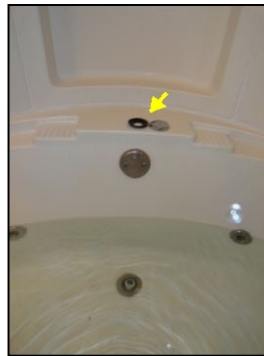
- Appeared satisfactory and functional, at time of inspection.
- Whirlpool tub was filled to a level above the water jets and operated to check intake and jets. The tub was then drained to check for leaks and/or damage. Pump and supply lines were not completely visible or accessible. The items tested appeared to be in serviceable condition, at time of inspection. If a more detailed report is desired, the client is advised to consult a licensed plumber for a complete review prior to closing.
- Drain at whirlpool tub needs repair attention.

Tub needed drain cap removal in order to drain.

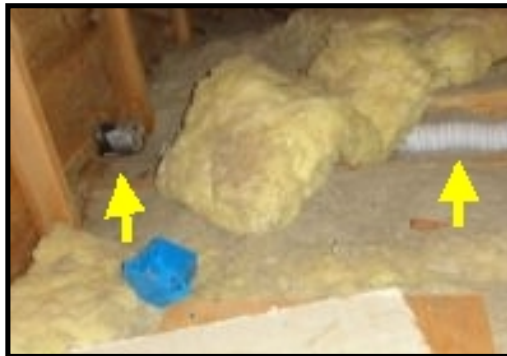
- Masterbath fan vent exhaust conduit has disconnected in attic.

Exhaust conduit needs to be refastened to exterior vent.

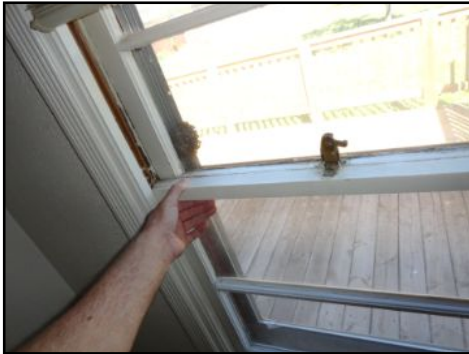
Some windows were stuck in jams.

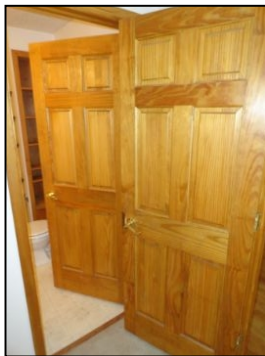
No discrepancies. The doors are in good condition.

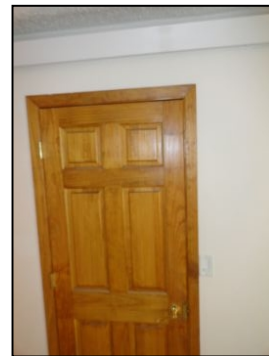
Each door closed and latched properly.

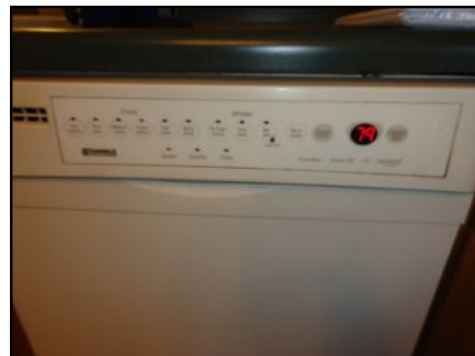
Appeared to function properly.
